Dynamic damage characterization of slender masonry structures by radar interferometry: a case study

Section: RESEARCH PAPER

The proposed work aims to evaluate the effectiveness of the interferometric radar technique for the dynamic damage identification of a slender masonry structure: the lighthouse of “Punta San Cataldo” located in Bari. In particular, Ambient Vibration Tests (AVT), according to the Operational Modal Analysis (OMA) technique [24]-[26], were performed since it does not involve the use of external forces that could damage the lighthouse structure. In some recent works [27]-[37], AVT has also been considered in developing innovative and advanced structural health monitoring systems based on the IoT paradigm.

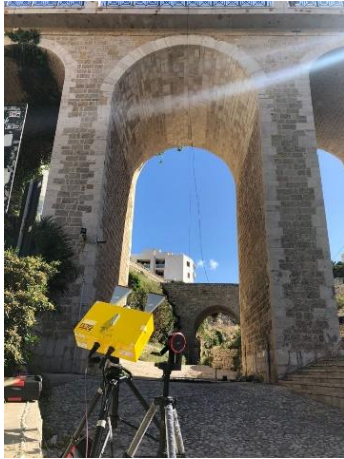
Figure 1. The interferometric radar system [18].

The ground-based radar interferometry (Figure 1) represents one of the remote sensing techniques that is proposed as a substitute for the methods used up to now for structural monitoring, as it is able to overcome the typical limits of accelerometric sensors [12]-[14].

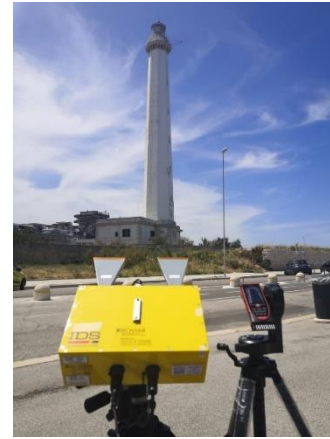
Figure 2. San Cataldo’s lighthouse in Bari.

The case study regards an historical masonry lighthouse located in Bari: the San Cataldo’s lighthouse (Figure 2). The structure was built on the Bari seafront between 1967 and 1969 and has the following geometrical features: a service structure with a main front of 24.00 meters and a lateral front of 12.25 meters, and the tower, which is about 61.00 meters high.

The tower shows a tapered shape and has an octagonal plan with a diameter of approximately 8.80 m at the base and 5.00 m at the top. The thickness of the walls varies from 2.90 m at the base to 1.00 m at the top. Moreover, the tower encloses a helical staircase.

kind of antennas pair (Figure 2), and a PC for managing the tests and storing the signals.

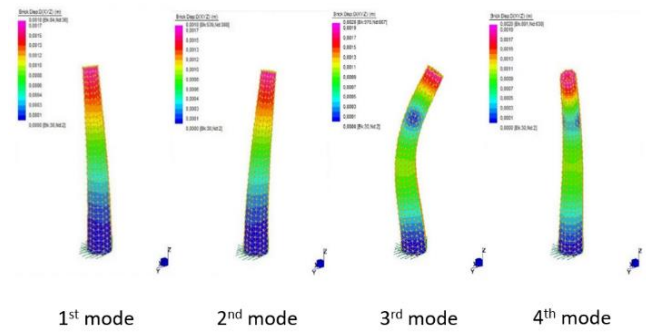
Figure 5. Numerical results: mode shapes and frequencies.

frequency that we have experimentally determined correspond to the third frequency of the structure.

Figure 5 show the first four modal shapes and the related frequencies of the undamaged lighthouse obtained by the numerical model in the hypothesis of an average Young’s modulus equal to 3300 MPa, a Poisson ratio of 0.2, and a material density of 1631.52 kg/m³.

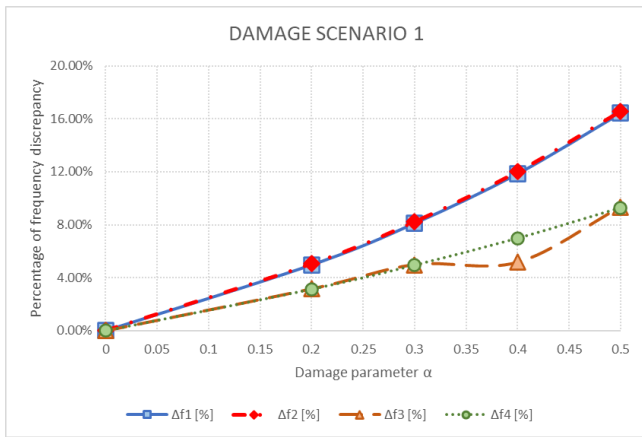
Figure 7. First damage scenario.

The first damage scenario reproduces a damage that takes place at the base of the lighthouse (Figure 7). In the graphs, the damage parameter α is on the x-axis, and the percentage change of frequency is on the y-axis. These lines represent percentage changes of the first four frequencies of the model as function of the damage parameter.

As it can be seen, all the four frequencies are sensitive to the damage. In particular, the first and the second ones are the most affected. For example, a decrease of 50 % of the Young’s

modulus correspond to a 16 % of variation of the first and the second natural frequencies.

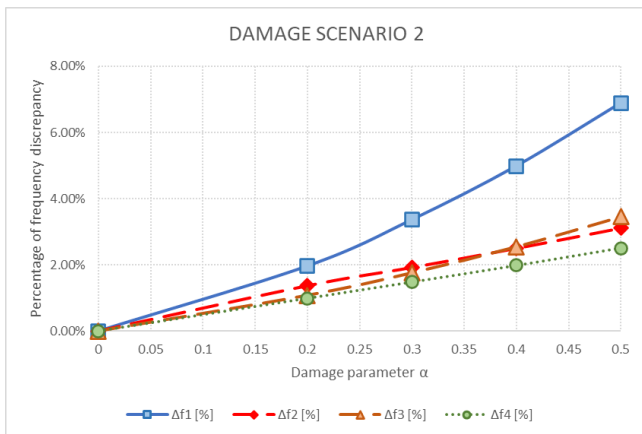
Figure 8. Second damage scenario.

The second damage scenario (Figure 8) is similar to the first one, but the damaged area is more limited. Also in this case, the four frequencies are all sensitive to the damage, although less than the previous case. For example, a decrease of 50% of the Young's modulus correspond to a 7% of variation of the first natural frequency. Here, the first frequency is the most affected.

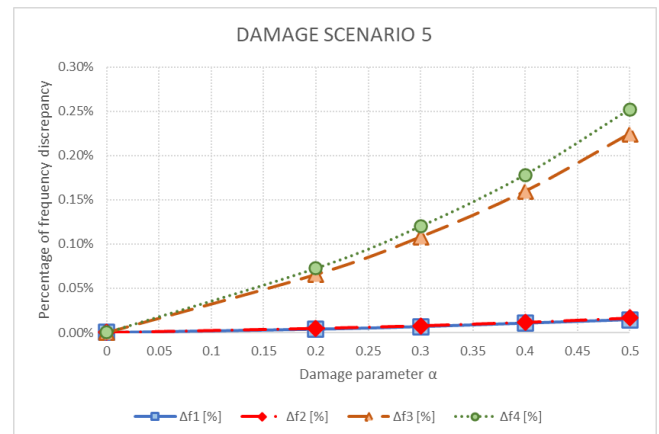
Figure 11. Fifth damage scenario.

The fifth scenario (Figure 11) is similar to the previous one but regards a more limited area. Also in this case, the frequencies are poorly affected by the damage.
