# Structural Health Monitoring of the Roman bridge S. Angelo on the Savuto river (Scigliano, Italy), by integration of a new sensor and geomatic techniques

Serena Artese<sup>1,2</sup>, Michele Perrelli<sup>1</sup>

**Section:** RESEARCH PAPER

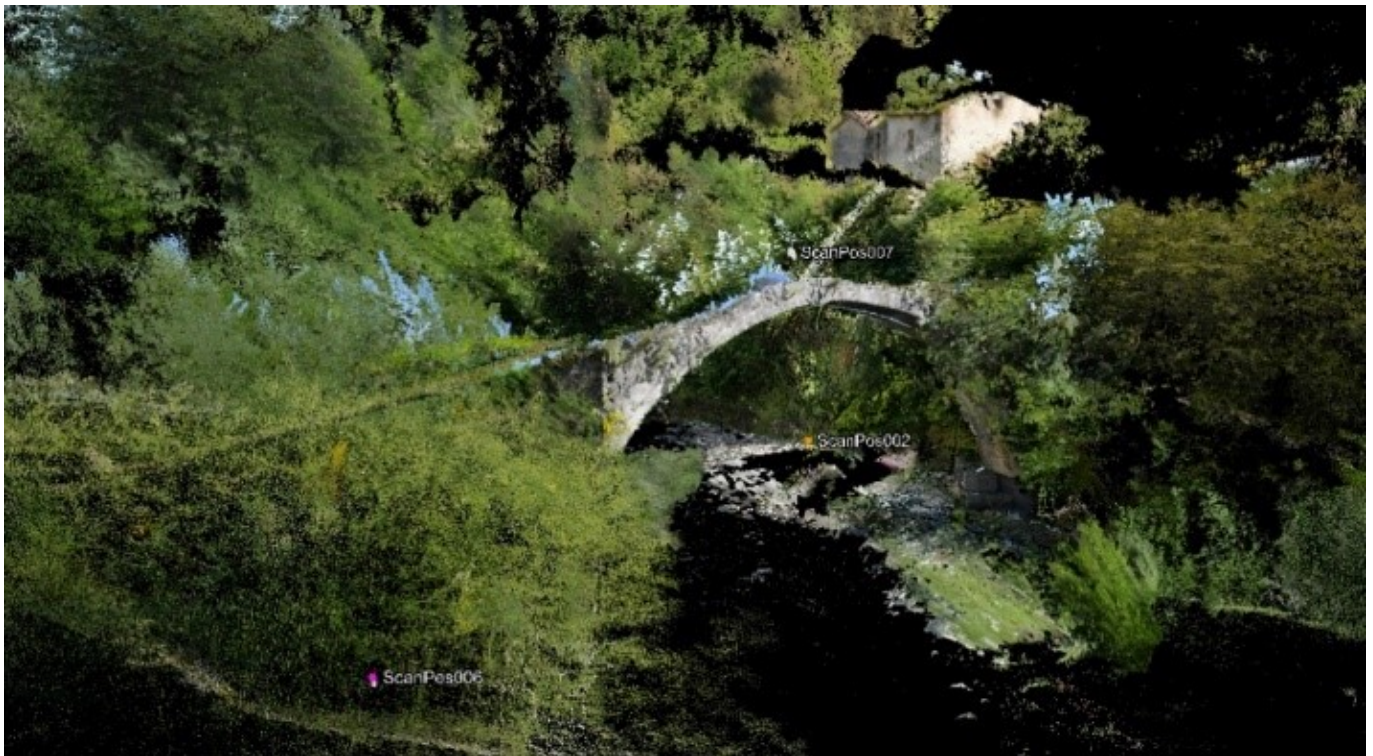
Figure 2. The union of the point clouds of *S. Angelo* bridge.

It is the *S. Angelo* bridge, also known as the *Devil's* or *Hannibal's bridge*, in the municipality of Scigliano (Figure 2, Figure 3). The *S. Angelo* bridge must be placed chronologically in the Trajan-Hadrian period [20], [21].

The first accurate survey of the building and the surrounding area [23] made it possible to obtain a geometrically accurate model. An estimate of the accuracy of the model can be provided by the deviations between the mesh obtained and the merging of the point clouds. In fact, despite the presence of dense

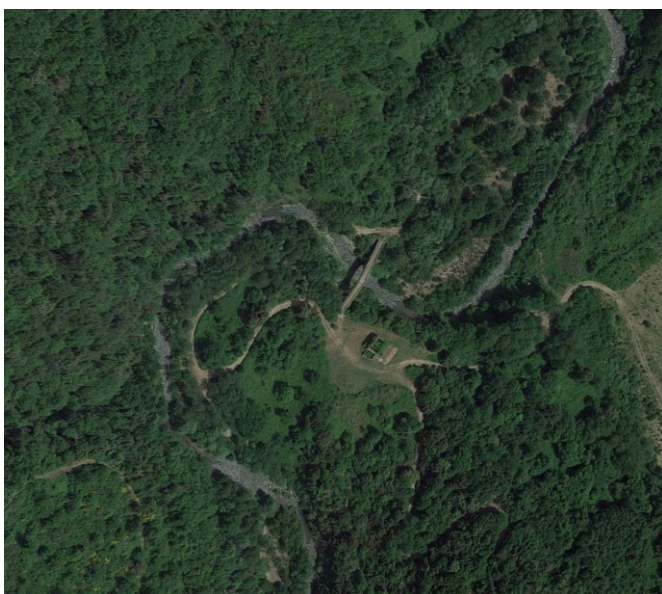
Figure 3. The *S. Angelo* bridge crossing the Savuto river.

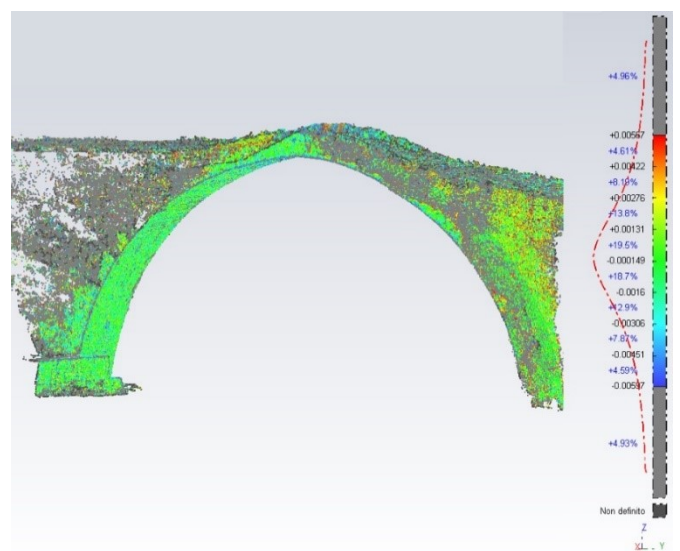
Figure 4. Differences between complete point cloud and mesh.

vegetation, the distance from the mesh is less than 6 mm for 90% of the points (Figure 4). The results of the investigation made it possible to confirm some hypotheses about the origin of the bridge. The span of the bridge is a confirmation of its Roman origins, given its value equal to 75 Roman feet, with a centimetre approximation, lower than the construction tolerances of that

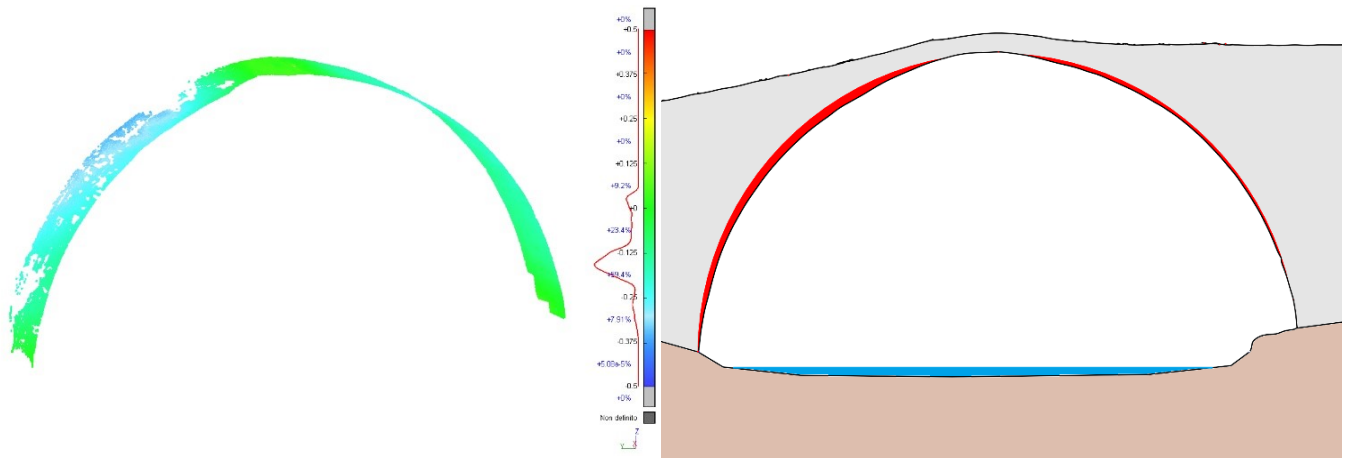
Figure 5. Differences between the ideal vault and the bridge intrados.

time. The heights of the arch springing are different on the two banks; the one corresponding to the right bank is about 1.10 m higher. An additional consideration can be made on the shape of the arch: there are two slightly lowered areas with respect to the theoretical arc of a circle.

The cause of these settlements is most likely attributed to the disassembly phase of the wooden centring which was used to lay the blocks of the dry-joint arch.

Figure 5 shows the 3D (left) and 2D (right) views of the deviations between the intrados of the most probable design arc and the mesh obtained from the TLS survey. We can observe that most of the points have a negative deviation with respect to the theoretical cylinder; this is explained by the fact that the form of the project was deduced considering the springing and the keystone of the arch as obligatory points.

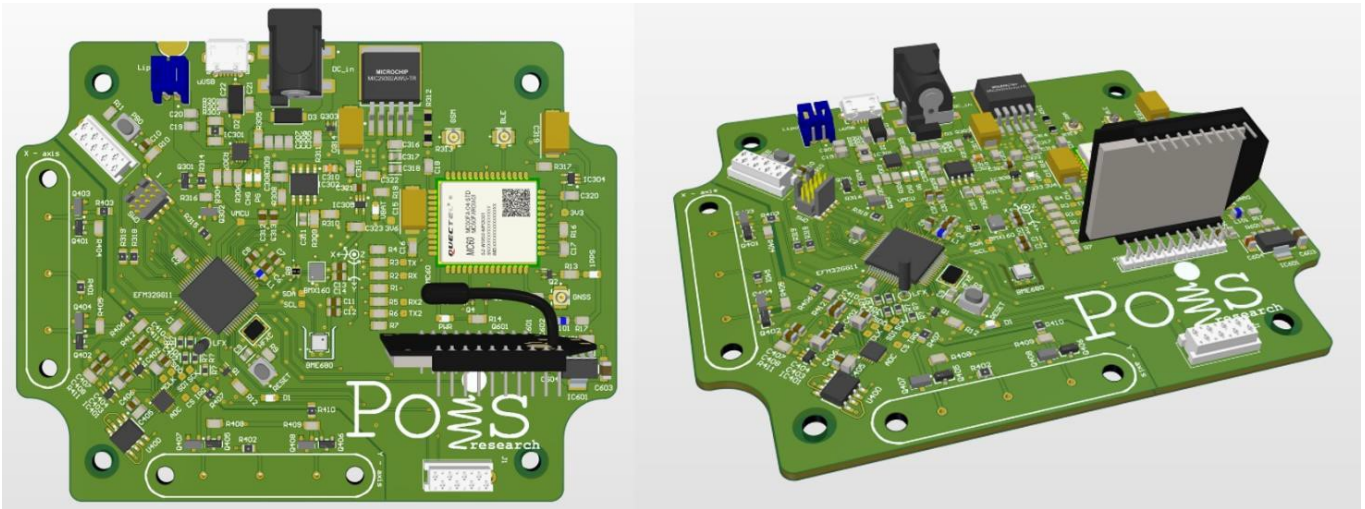
Figure 7. The POIS 2.0 multisensor card.

POIS 2.0 is the evolution of the POIS sensor (Position and Inclination Sensor), developed a few years ago by Spring Research, a spin-off of the University of Calabria [24]. Characterized by reduced dimensions and weight, this version also differs from the first prototype in terms of reduced energy consumption. Another peculiar feature is the capability to house and manage different types of elementary sensors (environmental parameters, air quality, etc.). The core of the system is a 32-bit microcontroller which manages the acquisitions from various elementary sensors, namely: a) a 6-axis IMU sensor (IIM42652) which communicates through an I2C serial bus; b) a humidity, pressure and temperature sensor (BME688 IAQ) on I2C serial bus; c) two electrolytic inclinometer sensors which communicate through an SPI serial bus. These sensors (Fredericks Company's 0703-1602-99) provide measurements within  $\pm 25^\circ$  with an accuracy of  $\pm 0.005^\circ$  on one axis. Featuring DC power, they have been industrially

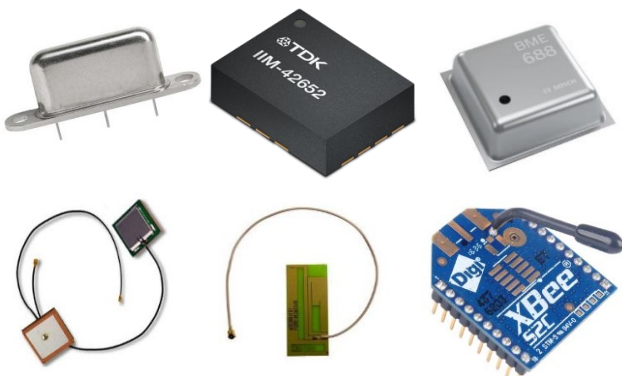
Figure 8. Components of POIS 2.0. From top-left clockwise: The electrolytic tilt sensor, the IMU sensor, the meteorological data sensor, the XBee module, the GSM/GPRS antenna, the GNSS antenna.

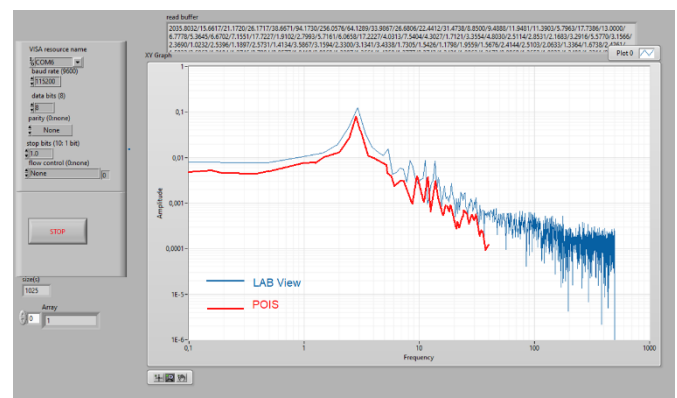
Figure 9. Frequency analysis of accelerometer data: the FFT obtained from POIS and the raw data processing via LABView are compared. For the processing of the POIS, frequencies in the range 0 – 30 Hz were considered.

In Figure 9 we can observe the comparison between the results obtained in the processing carried out via LABView and the POIS processor. Graphs obtained in arbitrary units were scaled to facilitate comparison. The graphs were obtained using the Z component of the acceleration to which the POIS card was subjected during a laboratory test. The Fourier transform of the data provided by POIS is compared with that obtained by LABView on the same raw data, with good accordance between the results.

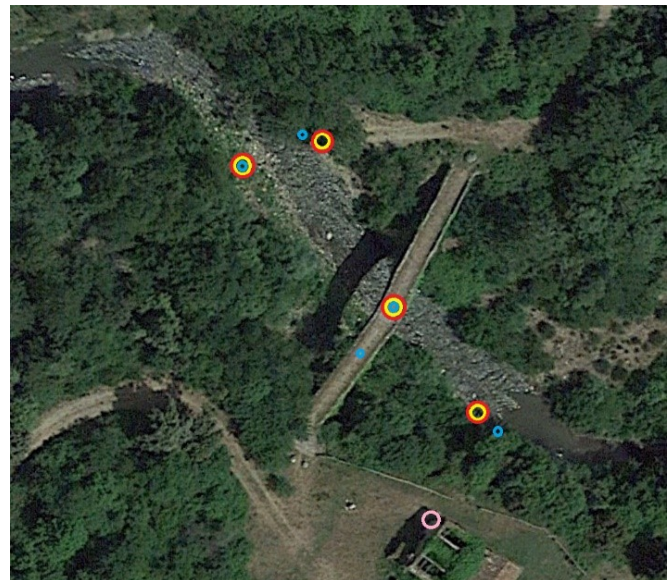
Figure 10. The layout of the periodic survey.

Figure 10 shows the layout of the geomatic survey. Red circles indicate TLS stations, yellow circles the GNSS stations, and blue circles the cylindrical targets used for the TLS point cloud registration. Two corners of old buildings have been chosen as reference; one of these (the north corner of the church of S. Michele) is highlighted in the figure with a pink circle. One can see that some points are simultaneously TLS station, GNSS point and target (Figure 11, Figure 12).

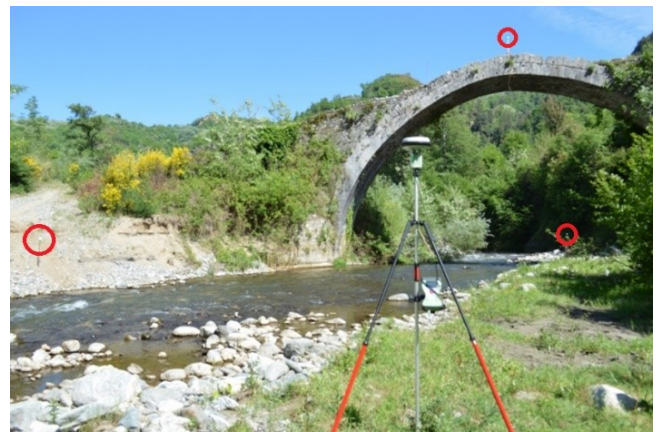
Figure 11. GNSS receiver on a TLS station point. Three targets, circled in red, are visible.

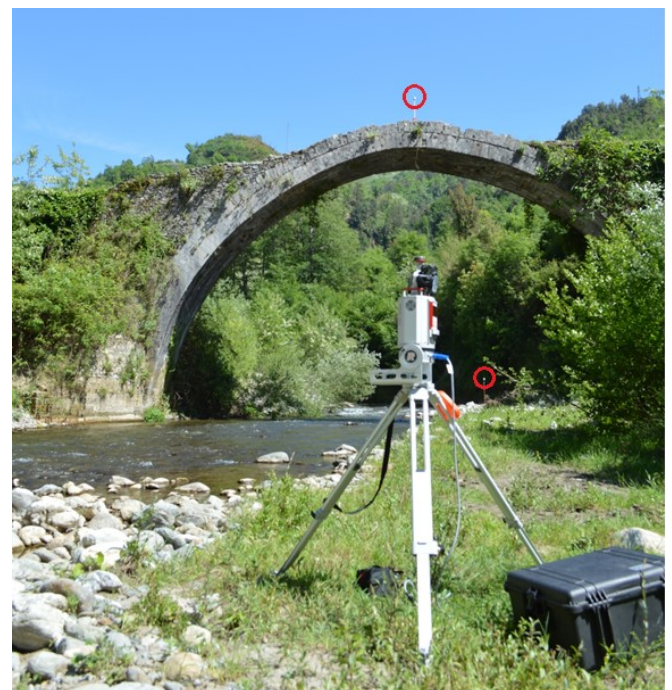
Figure 12. The TLS on a station point. Two targets, circled in red, are visible.

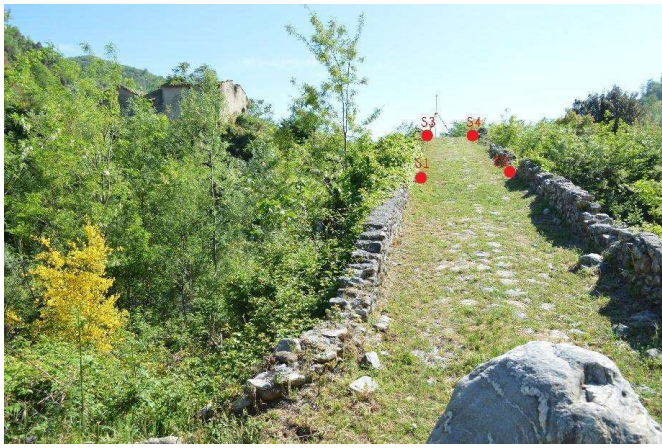
Figure 13. The positioning of the POIS 2.0 sensors on the extrados of the bridge.

Six POIS 2.0 sensors have been positioned on the structure of the bridge; four were fixed on the extrados, in correspondence with the keystones and about four meters away, while the other two were positioned near the springs.

Figure 13 shows the positions on the extrados where the Pois sensors have been installed. At the moment, the measures for the

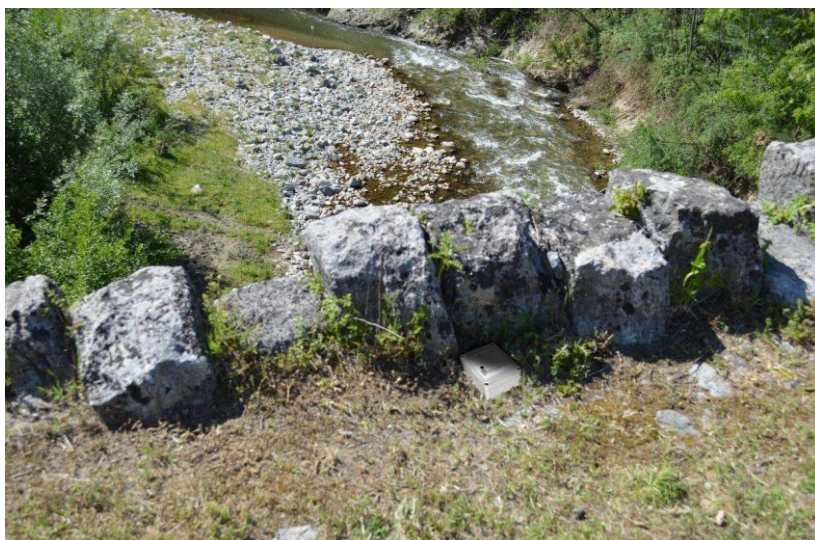
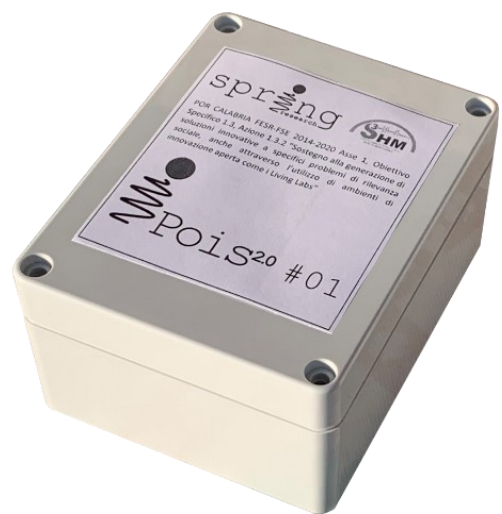
Figure 14. A POIS placed on the extrados of the bridge (left) – The sealed case of the sensor (right).

The sensor POIS 2.0, positioned on the extrados of the bridge, is shown in Figure 14, along with the sealed case of the multisensor.
