Diagnostic investigation of the wall paints conservative state in a hypogeal room of the archaeological park of Baia (Italy)

The present study investigated the correlation between the degradation processes of cultural heritage and the environmental parameters of the semi-confined site that houses it. The latter is a semi-underground room (*nymphaeum*) found in the Archaeological Park of Baia (Italy) dating back to the third century; it is decorated with marine motifs and painted with frescos techniques from the same period. Relative humidity and temperature were hourly registered, and the collected data were used to derive daily and annual profiles. The effects of microclimate induced degradation were investigated employing various techniques, such as Ion Chromatography for the chemical characterisation of deposits, and Thermography, for the individuation of biological layers. The data obtained showed that the underground environment, partially submerged by rising brackish water, was affected by the presence of biodeteriogens, whose distribution and growth is strongly favoured, above all, by the environmental parameters and by the substrate characteristics. All the data were then

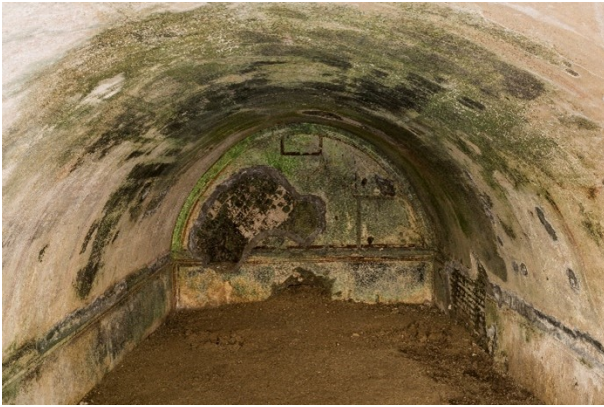
Figure 1. Frontal photo of room SB-E0-R07, taken from the entrance. Biodegradation is evident, particularly on the back wall and on the ceiling.

The hypogeal space known as SB-E0-R07 (Figure 1), the main subject of the present work, as well as the adjacent *nymphaeum* (Figure 2), both located in the northern area of the Mercury's sector, constitute a valuable opportunity to describe any potential correlation among the variety of degradation phenomena affecting underground environments. Despite the proximity, these semi-confined spaces present several dissimilarities. Although probably connected, and only located at the short distance of two meters from each other, their respective grounds present different heights due to bradyseism. As a result of this phenomenon, the second chamber has about 20 cm of brackish water on the lining. A further difference lies in the presence of frescos paintings on the north-eastern wall of SB-E0-R07 (Figure 3), whereas the adjacent *nymphaeum* presents decorations only on the upper frame. These mural paintings date back to around the I or II century A.D., a time framing supported by the massive use of brickwork for the surrounding structures [13], [14].

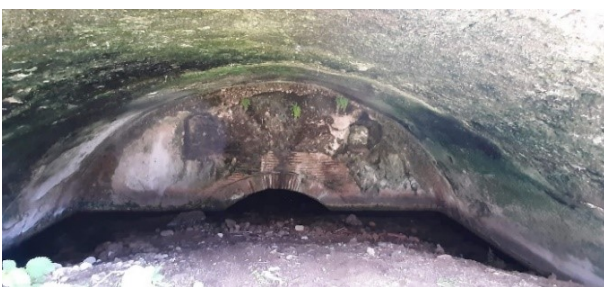
Figure 2. Frontal photo of the nearby *nymphaeum*, with the clear presence of brackish water on the lining.

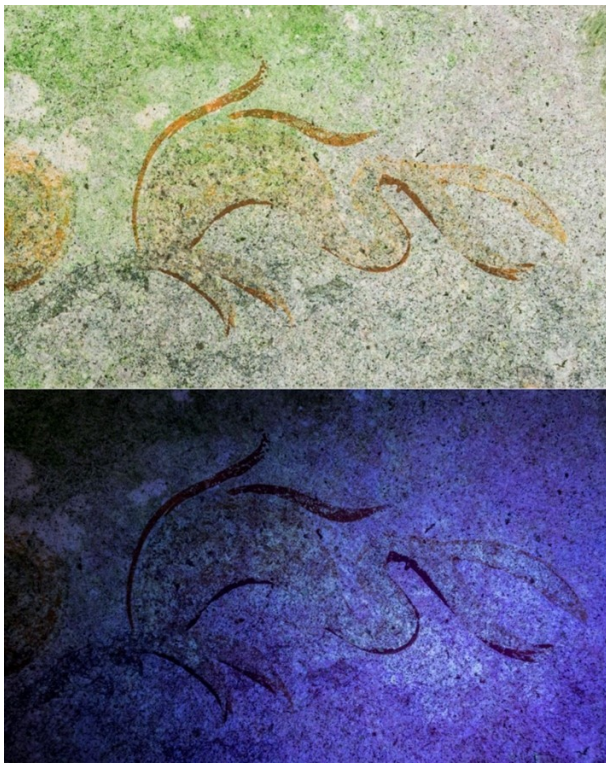
Figure 3. Detail of mural painting, partially covered with biofilm. Top is taken with natural light; bottom is fluorescent after exposition to UV light, obtained using a portable UV lamp (395 nm, Eletrot).

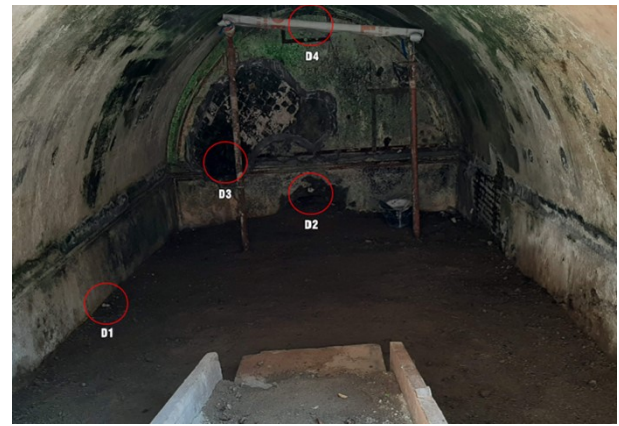
The environmental parameters of SB-E0-R07 and of the adjacent room were investigated to characterize the ties between microclimate and degradation. Variations of humidity levels and temperature were measured along the horizontal and the vertical axis (external-internal and inferior-superior respectively), for the duration of one year, employing four data logger ORIA[®] 2 Pack Wireless Thermometer Hygrometer (temperature range - 20/60 °C, ±0.5 °C; humidity range 0-99 % RH, ±5 % RH). Data was collected during two weeks per season (on an hourly base), to trace a daily, seasonal, and annual profile. Each datalogger was put in the border area of the room across the horizontal and vertical axis, to ensure an efficient monitoring of the whole environment (points D1-D3 and D2-D4 in Figure 4, respectively).

Figure 4. Position of the datalogger for the registration of microclimatic parameters.

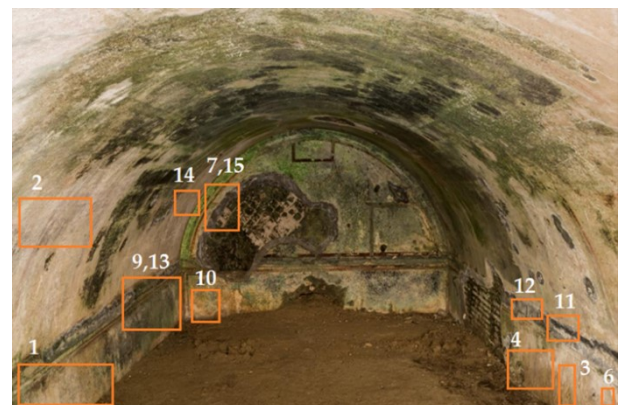
Analysis of saline efflorescence was carried out to investigate the predominance and spatial distribution of detected chemical species. Surface samples were collected at different heights and at different distances from the room entrance (Figure 5), following the vertical and horizontal axis, to highlight the variation in composition of salt species and to verify any correlations with other degradation phenomena. Samples 11 and 12 were collected from the concrete layers in the lower part of the wall on the right; sample 2 was collected from the north wall of the hypogeum, near to the entrance and in an area interested by rainwater infiltration due to the presence of a hole in the ground above. Samples 3 and 6 were collected from the south-east wall, influenced by the thermal water migration from the

bordering nymphaeum and from the room below. Samples 1 and 10 were collected in wall sections previously underground. Finally, samples 1, 7, 9, 14, 15 were collected at points interested by a significative presence of biodeteriogens. Before chemical analyses, samples were gently dried, using a drier with silica gel, until a constant weight was reached; an aliquot of each sample was then treated with ultrapure water and sonicated to allow extraction of soluble constituents. Solutions were later filtered using membranes with pores' size of 0.2 mm. Pre-treated samples were finally analyzed using the ion exchange chromatography system Dionex IC-1100 with a double line for anions and cations determination (Cl^- , F^- , Br^- , NO_2^- , NO_3^- , PO_4^{3-} , SO_4^{2-} , HCOO^- , CH_3COO^- , $\text{C}_2\text{O}_4^{2-}$, Na^+ , K^+ , NH_4^+ , Ca^{2+} and Mg^{2+}); compliance method and accuracy were discussed in [16].

Figure 5. Map of picking spots of salts present in room SB-E0-R07.

Among the considered samples, 13, 11 and 4 show the highest sea-salt contribution, with values of 325, 39 and 20 mg/g respectively; these samples are all collected from the lower section of the walls and present clear signs of moisture (see Figure 4).

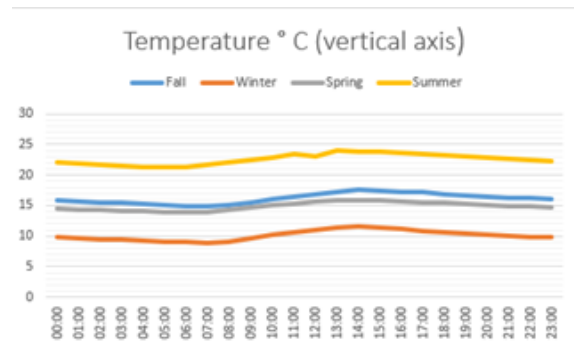
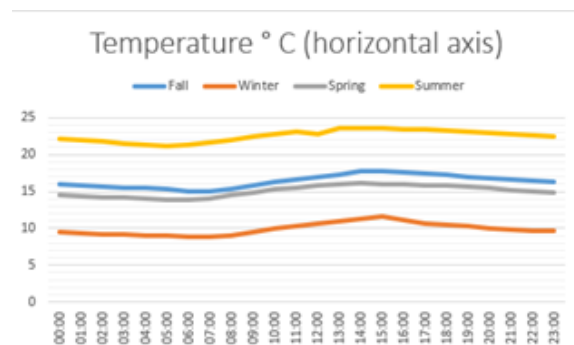
Data in Figure 6 to Figure 9 showing microclimate parameters' fluctuation in room SB-E0-R07 portray thermal and humidity daily trends as broadly stable. Temperature profile indicate only a 2 °C daily excursion in both the perpendicular and parallel sections of the room, consistently with what's expected in underground spaces [6]. Slightly clearer variations are instead observable in the measurements of humidity rate which, while only varying by about 3 % on the horizontal axis, especially in the cold months, show a more significant shift of 6 % along the vertical axis in all seasons. Observing the hygrometric variations (Figure 6 to Figure 8), decreases in overall values around 2 pm are apparent, with a slow degradation towards the minimum starting at about 12 am. These data are fully reflected by thermal measurements (Figure 7 to Figure 9); in fact, at the same time the humidity rate drops, peak temperature is reached.

This is likely explained by the exposition to sunlight of room SB-E0-R07, which is usually highest between 1 pm and 3 pm, leading to an increase in temperatures and a lowering in humidity, particularly in the areas close to the entrance. After 2 pm, a slow increase in the hygrometric rates is evident and a decrease of the overall temperatures follows, corresponding with the evening time slots. The general stability of indoor temperature and the regularly high relative humidity are surely caused by the influence of thermal water present in the nearby nymphaeum and under room SB-E0-R07, complimented by the hypogeal nature of the whole structure.

Figure 6. Seasonal trend of hourly relative humidity for the vertical axis.

Figure 7. Seasonal trend of hourly temperature for the vertical axis.

Figure 8. Seasonal trend of hourly relative humidity for the horizontal axis.

Figure 9. Seasonal trend of hourly temperature for the horizontal axis.

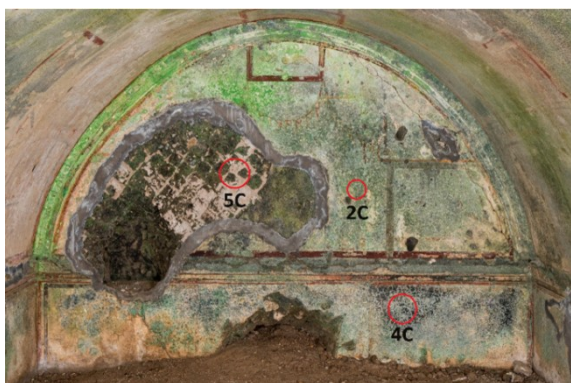
Figure 10. North-eastern wall of SB-E0-R07, showing the three sampling spots: 2C, 4C and 5C.

Luca *et al.* [17], Actinobacteriota are prevalent on the exfoliated section, mainly composed of limestone (5C), as opposed to the plasters (2C, 4C); on the other hand, while Cyanobacteria are similarly represented in all samples, Chlorophyta (green algae) seems to only be prevalent among eukaryotes in samples 5C and 2C, both found in the upper regions of the wall.
