The Heritage Building Information Modelling System for non-destructive optical techniques: The case study of the restoration of a Marble sculpture on the façade of the Gesù Nuovo Church in Naples

Section: RESEARCH PAPER

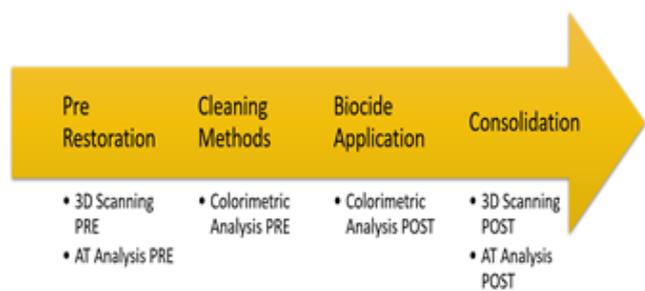
Figure 1. Timeline of the restoration work and measurements carried out.

totally sustainable way, with few toxic products for humans and the environment, respecting the criterion of minimum intervention. In particular, the cleaning was carried out with only sodium bicarbonate and Agar-agar gel. The other operations, related to the non-destructive diagnostic analysis, concerned the consolidation, cleaning and use of an essential oil-based biocide. In pre-consolidation, water based 30 % nanosilica was used. In addition, a natural biocide based on three essential oils has been tested by comparing its effectiveness with a traditional biocide whose results are well known. The success of this methodology, compared to the "traditional" one, used for the rest of the marble compositions, has given excellent final results and the confirmation has also been given by diagnostic analyses (Figure 1).

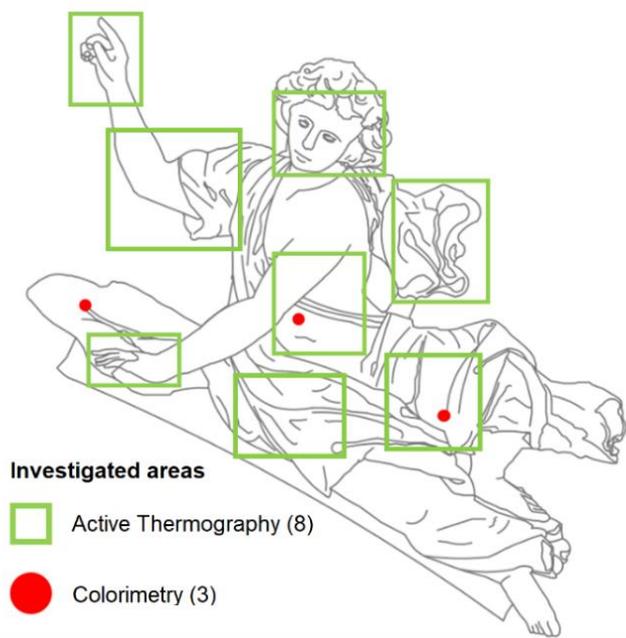
Figure 2. Mapping of the areas investigated on the statue by the use of Active Thermography (green squares) and colorimetric analysis (red circles).

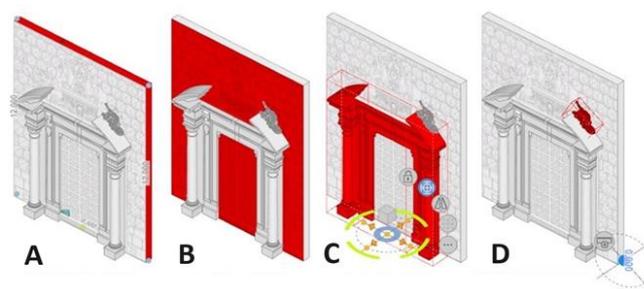
Figure 3. Inclusion in Edificius: The various elements have been inserted in different formats: AB) the ashlar, which characterises the façade, has been inserted as a texture/orthophoto applied to the *Involucro* object; C) the portal was made in CAD as an ideal model and D) the sculpture was imported as a reality-based model, textured photogrammetric mesh.

Only the areas of the façade of interest have been broken down and modelled: the central portal and the sculpture that is the subject of the study, reasoning by semantic deconstruction (Figure 3). The 3D model of the entire sculpture was made using digital photogrammetry. The photogrammetry technique makes it possible to identify the spatial composition of all points on the object. It is a surveying technique that allows important information about physical objects and the environment to be obtained through the process of recording, interpreting and measuring photographic images. This sculpture was processed using the photogrammetry software developed by 3Dflow to reconstruct 3D models from photographs, 3DF Zephyr [24]. The photographic images were taken with a mobile phone: Oneplus 5T, 16-megapixel camera with a resolution of 4638×3436 pixels and thanks to the use of markers. Six markers were used and placed on the mortar base of the sculpture (two on the front and two on the back, one on the right and one on the left) placed 35 cm apart. Thanks to the orthophotos elaborated by the photogrammetric model, it was possible to elaborate the various thematic mappings, necessary for the documentation of the work and to support the restoration activities. In addition, a unified visibility of the sculpture, lost with the presence of the scaffolding, was recovered (Figure 4).

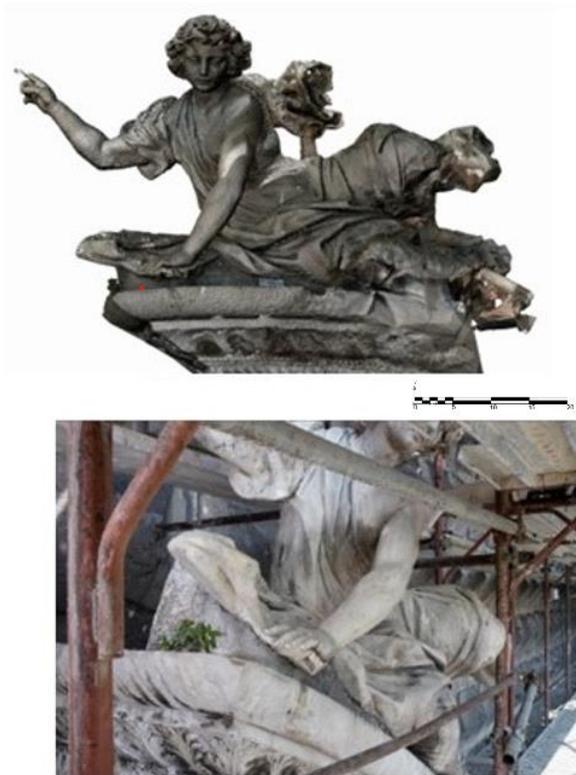
Figure 4. Textured photogrammetric mesh and the photo of the sculpture on the construction site.

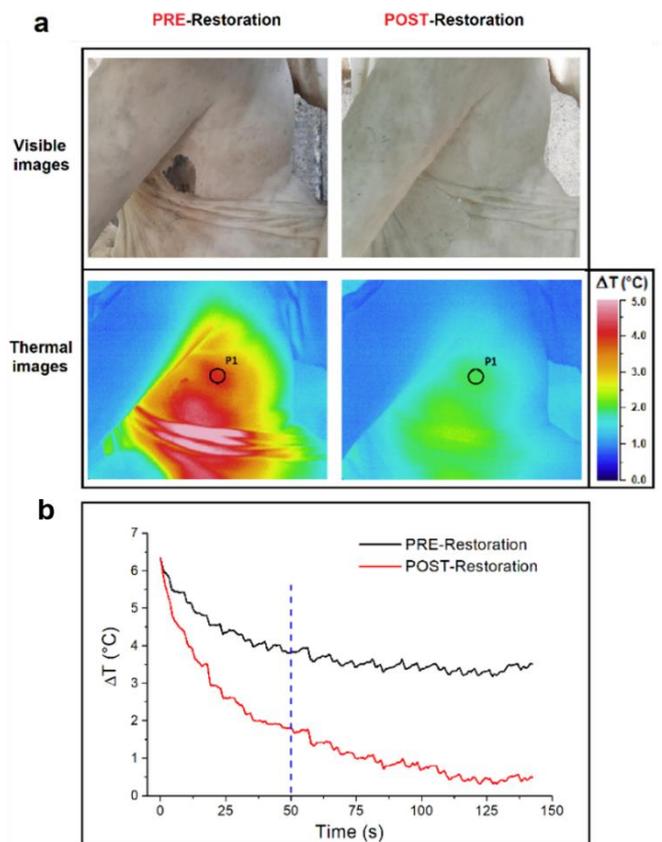
Figure 5. Example of AT analysis carried out on an investigated area of the marble sculpture: a) thermal and visible images acquired before (PRE) and after (POST) the restoration work, b) PRE (black line) and POST (red line) temporal thermal trend of the area P1.

As an example, Figure 5a shows the visible and thermal images obtained both in the PRE and POST phase of one of the

analysed areas of the sculpture referring to the body. The thermal image refers to the induced thermal gap ΔT measured 50 s after an external stimulation heating and achieved by subtracting the thermal frames $\Delta T = T(t = 50) - T(t = 0)$ extrapolated from the recorded sequences $T(t)$. As visible from the images, the average ΔT referring to the inspected area obtained in the PRE-phase is about 4 °C and therefore almost double compared to that measured in the POST-phase of about 2.2 °C.

It is interesting to note, the difference in ΔT is relevant not only in the area affected by a black crust (well evident in the visible pre-restoration image) but also in all the surrounding surface. The latter is due to the presence in the PRE-restoration phase of a thin contaminating patina which affected most of the inspected surface, not visible to the naked eye but detectable by the thermal analysis carried out.

Figure 5b shows the temporal thermal trend extrapolated in the PRE- and POST-restoration analysis of the P1 region (indicated in thermal images in Figure 5a referring to an area of the surface of the sculpture where no crusts or contamination are visible to the naked eye). As can be seen, the PRE-trend (black line) shows a slower thermal recovery than the POST-trend (red line) as an effect of the presence of the contaminating patina eliminated during the restoration works.

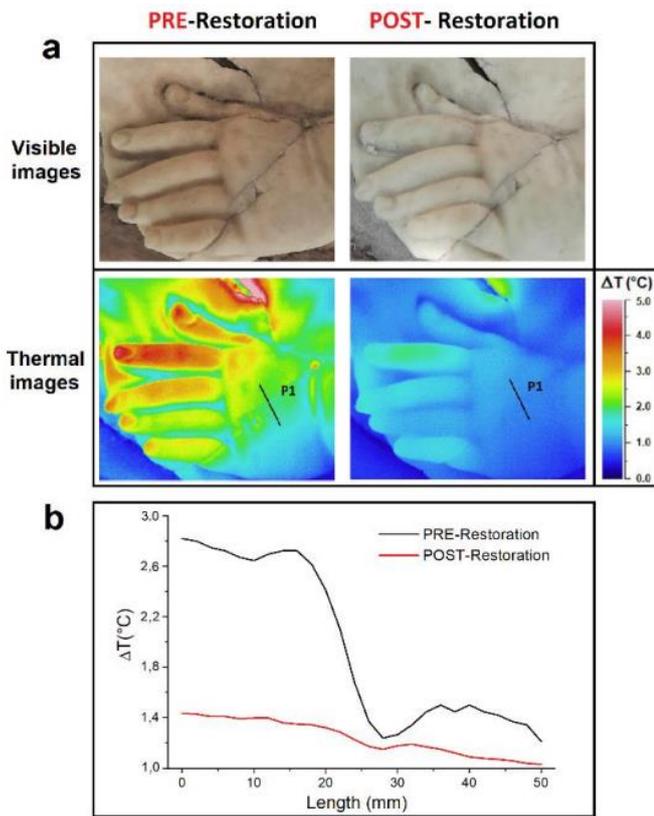
Figure 6. AT analysis of the hand of the marble sculpture investigated: a) thermal and visible images acquired before (PRE) and after (POST) the restoration work, b) PRE (black line) and POST (red line) spatial temperature profiles referred to the P1 lines indicated in the PRE and POST thermal images.

visible solar spectrum. Consequently, the contaminated surfaces of the sculpture are affected by both a greater overheating during the daily cycle (especially in the hottest hours) and a slower heat dissipation. Basically, the presence of such crusts and patina on the sculpture can lead over time to serious problems of degradation and deterioration due to the greater thermal stresses affecting these areas. Figure 6 shows the AT analysis referring to the hand of the sculpture.

As can be seen, the PRE-restoration measurements highlight how the fracture visible on the hand delimits two areas with very different thermal responses. This was presumably due to the presence of a subsurface void (cavity) into which air, humidity and rainwater entered through the crack. Their accumulation under the hand increased the thermal inertia and slowed down the natural process of heat dissipation. The comparison between the PRE and POST thermal images shows how this discrepancy in the thermal behaviour of the two parts of the hand was greatly attenuated after the local filling carried out during the restoration works.

Figure 6b shows the spatial temperature profiles referred to the P1 lines indicated in the thermal images in Figure 6a. The comparison of the PRE (black line) and POST (red line) measurements also confirms from a quantitative point of view how the two parts of the hand show a much more similar thermal response after the restoration intervention. It should be noted that in both examples shown the thermal differences found in the PRE and POST-restoration analyses are well above the Noise Equivalent Temperature Difference (NETD) of the infrared camera used of 0.05 °C and therefore can be considered

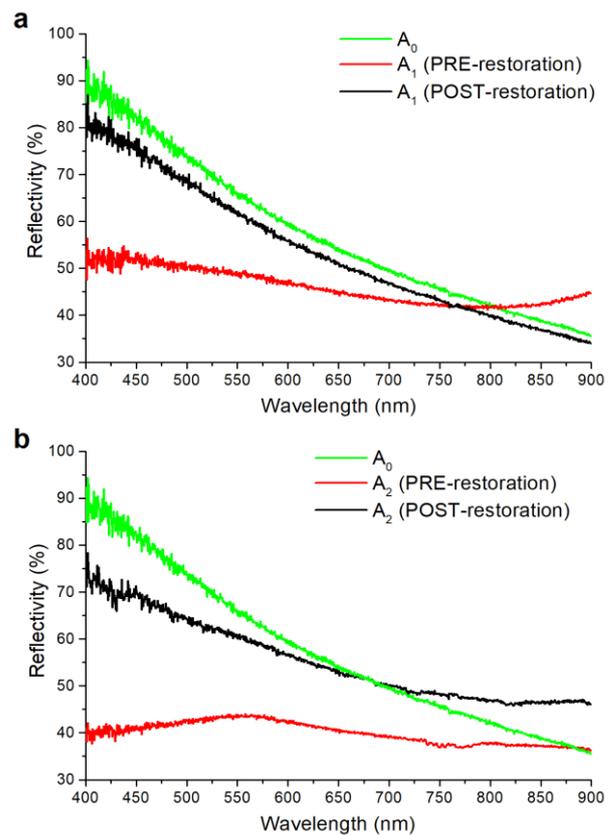
Figure 7. Reflectivity spectra measured on areas A1 (a) and A2 (b) PRE- (red lines) and POST-restoration (black lines) are reported and compared with that of the reference area A0 (green lines).

As can be seen by comparing the values obtained PRE- and POST-restoration, for both treated areas A1 and A2 all three parameters ΔL^* , Δa^* and Δb^* were reduced after cleaning, indicating a drift of the colour of these areas towards that of reference A0. Considering the standard deviations reported for each measurement, the comparison of results achieved before and after restoration show a clear non-overlap of the confidence intervals confirming as the variations of the parameters measured can be considered statistically significant. In Figure 7, the reflectivity spectra measured on areas A1 (Figure 7a) and A2 (Figure 7b) before (red lines) and after (black lines) the restoration work are reported and compared with that of the reference area A0 (green lines). As visible from the reflectivity spectra, the curves of A1 and A2 measured PRE-restoration are very different from that of A0 but both shift towards the latter in POST-restoration measurements. The POST spectrum referred to A1 better matches that of A0 than the POST spectrum measured for A2. Therefore, this analysis gave an indication regarding the results obtained from a colorimetric point of view through the restoration work, highlighting the areas of the sculpture where the cleaning intervention carried out was totally or only partially successful.

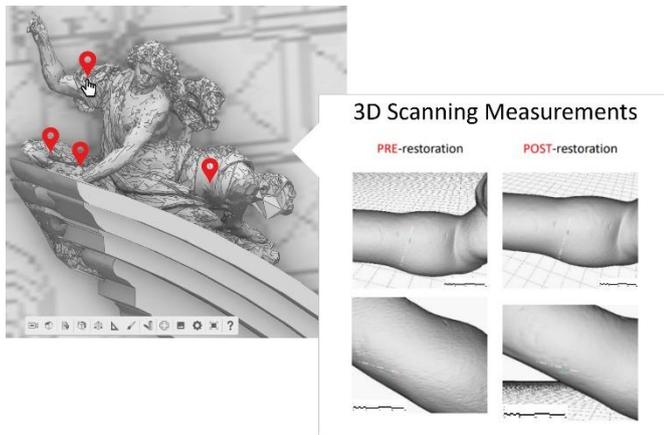
Figure 8. Results obtained from the 3D scanning that took place before and POST restoration inserted in the usBIM platform.

Thanks to the 3D scanning of the sculpture arm which, as mentioned above, showed a more advanced disintegration than the rest of the composition, it was possible to quantify the result of the consolidating effect given by the nanosilica basis and the lime water (Figure 8). It results that the restoration work has not

caused structural changes, but only a decrease in the surface roughness in some parts of the marble sculpture, i.e. the marble surface after the restoration work appears more compact and smoother. In Figure 8 it is possible to see and compare the success of the intervention directly on the platform.

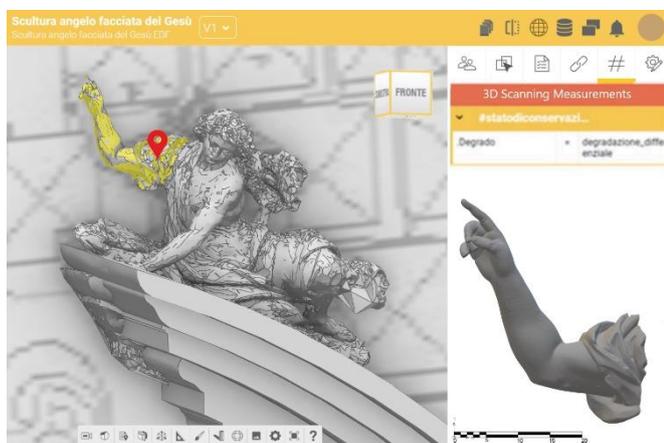
Figure 9. Scanning of the 3D model on the platform, also tagged to the type of degradation affecting the area and the intervention carried out.

In Figure 9 the 3D tag is directly linked to the degradation marker; the diagnostician can see the degradation area and at the same time decipher the result even during data processing. The goal is to make the most of the possibilities of this software and the sharing system to facilitate diagnostics as well. This method of online sharing not only allows you to have a digital bank where you can compare the results of the before and after restoration, but also a bank for the monitoring campaign. The ACDat can be structured in accordance with the proposed workflow.

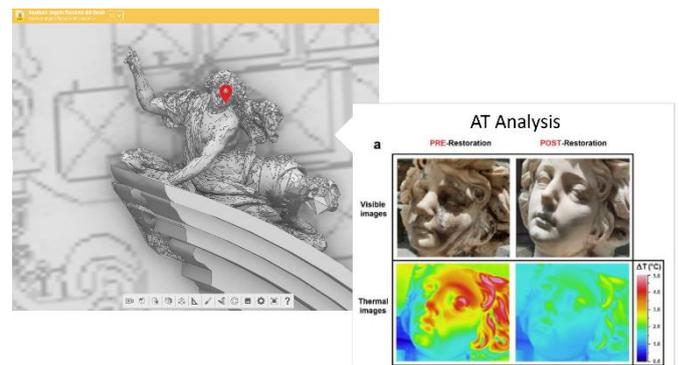
Figure 10. Sharing of the results of the thermographic analysis on the face of the sculpture on the usBIM platform.

All the shots taken can be entered into the usBIM platform of Acca Software which allows the sharing of the project. In this way, the diagnostician, together with the restorer, can share the results in real time on the model and the restorer can give more detailed explanations to the operator. In the case of thermography, it is possible to discuss the possible causes that led to an abnormal thermal behaviour: as in our case on the angel face which had a veil of black crusts that changed the behaviour of the material (Figure 10).

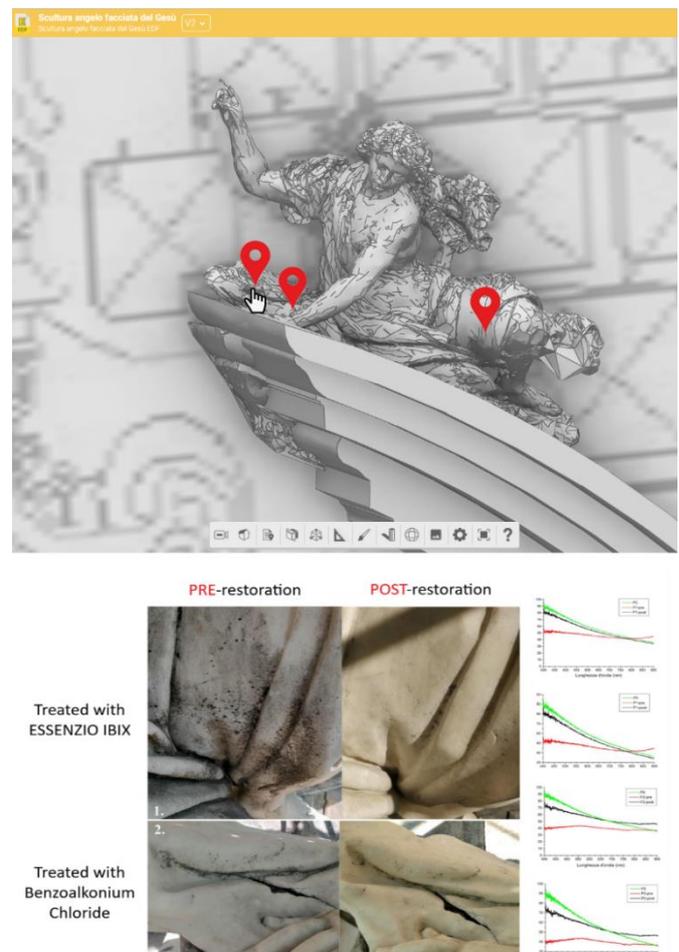
Figure 11. Sharing the two Colorimetric analysis results in two different markers.

diagnostician on the same area attach the results of the measurements. The software makes it possible to bring together different information from different operators. Since the model is online, it is possible to share it via links to all interested parties. In this way, communication between the various professionals is much easier and there is instant feedback. As we will see, the diagnostician can compare the results and process them with the help of the information uploaded by the restorer on the type of degradation or intervention. As anticipated, colorimetry was tested on two points treated by a different biocide: in part 1, biocide based on three essential oils and in part 2, Benzalkonium Chloride (Figure 11). The two markers on the two differently

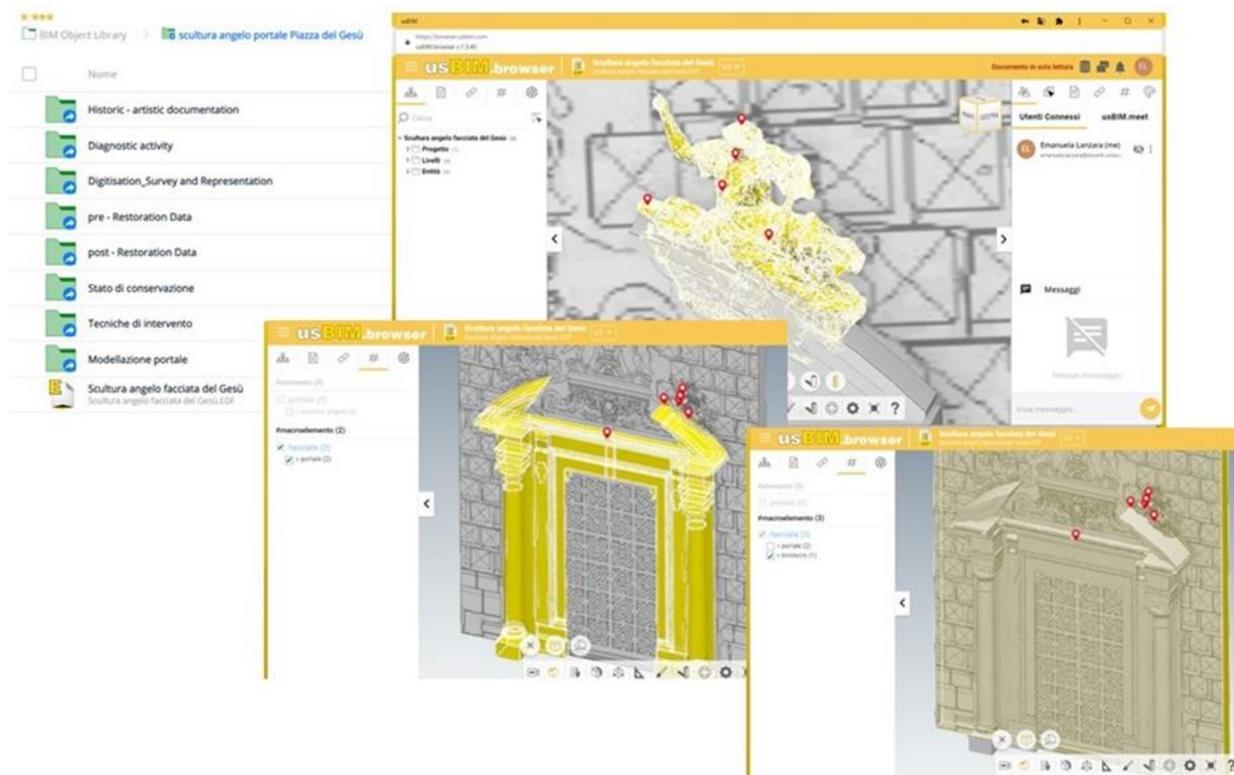
Figure 12. Layout of the program with all the markers, links and tags inserted in the template and the folders where it is possible to find the information individually.

treated areas can either contain the same type of information for a more immediate comparison or treat them separately. They can also be used in total autonomy by dividing them into subcategories. The information contained can also be subdivided and subcategories created. The organisation and geolocation of the information facilitate the search for the degradation information detected, NDT diagnostics and minimally invasive. The query of the system on the platform through markers, #tag and links facilitate the sharing of data and enriches the model with specific information referring to the work, the context and the operations carried out (Figure 12).
