# X-ray computed tomography for non-destructive evaluation of steel wire ropes: Comparison of laboratory XCT configurations for image quality and damage visualization

Steel wire ropes are critical structural components whose internal damage often cannot be reliably assessed using conventional non-destructive testing methods. This study evaluates the applicability of laboratory X-ray computed microtomography (XCT) for detailed inspection of steel wire ropes by comparing three complementary XCT configurations: one employing a liquid-metal anode microfocus source with a large-area flat-panel detector, a conventional sealed-type microfocus tube with CMOS detector, and a high-power X-ray source coupled with scintillating screen and a laboratory camera. Intact and damaged rope specimens together with an individual fractured steel wire were investigated under various acquisition conditions. Image quality was quantitatively assessed using the contrast-to-noise ratio (CNR) and the full width at half maximum (FWHM) of the line spread function, complemented by qualitative evaluation of reconstructed three-dimensional models. The results demonstrate the influence of X-ray source characteristi

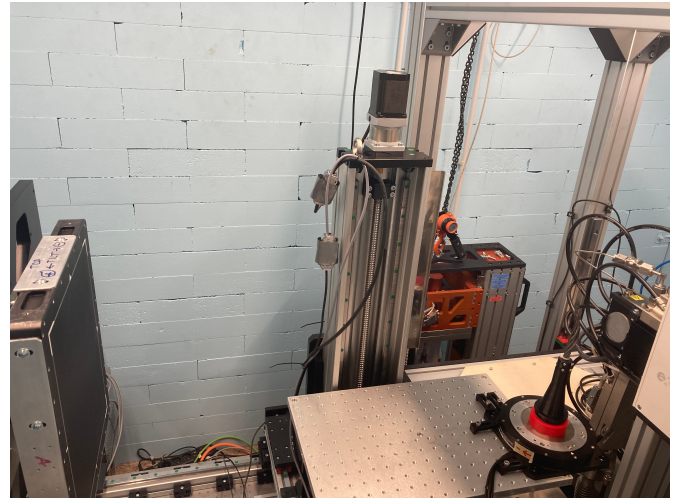
Figure 1. Experimental configuration employing a high-power liquid-metal anode X-ray source and a large-area low-noise flat-panel detector.

The first experimental configuration, shown in Figure 1, utilized an in-house developed XCT system equipped with a MetalJet D2+ liquid-metal anode microfocus X-ray source (Excillum AB, Sweden), a CsI flat-panel detector XRD 3025 (Varex Imaging, Germany) with a pixel pitch of  $100 \mu\text{m}$ , and a precision rotary stage carrying an X-ray transparent sample holder. The X-ray source was operated at an acceleration voltage of 160 W and a target power of 250 W with arbitrary focal-spot geometry set to approximately  $11 \mu\text{m} \times 20 \mu\text{m}$ . A 2 mm aluminium sheet and a 0.6 mm copper sheet were used for X-ray beam filtering to suppress low-energy components of the emitted spectrum. The reference acquisition protocol consisted of three consecutive full-rotation scans with a defined angular offset, each consisting of 1000 equiangular radiographic projections acquired at a native detector resolution of  $3008 \times 2512$  pixels. The individual projection sets were subsequently combined to form a reference dataset containing 3000 projections, following a multi-rotation acquisition strategy previously employed for dynamic XCT imaging [12]. Each projection was recorded using 1350 ms integration time. To assess the trade-off between acquisition time and reconstruction quality, additional scans comprising 2000 and 1000 projections were performed on the intact wire rope specimen while keeping all remaining imaging parameters unchanged. The applied imaging geometry resulted in an isotropic voxel size of  $16.5 \mu\text{m}$ , while the total acquisition time of the reference scan was approximately 138 min.

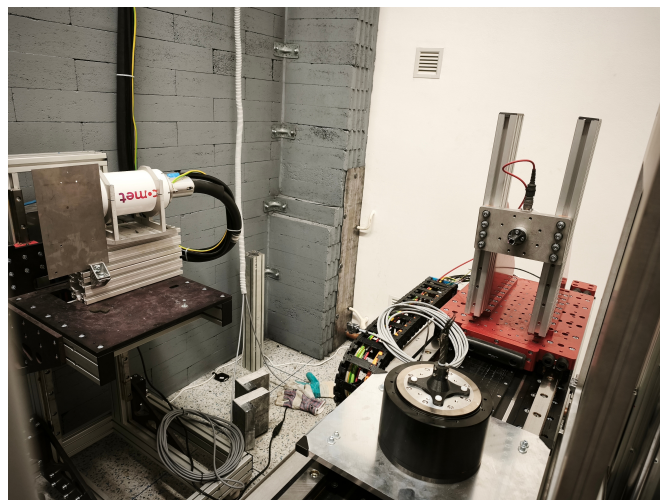
Figure 3. Experimental configuration employing a high-power X-ray source and a large-area scintillator-coupled detector for large-field-of-view XCT imaging.

The final experimental configuration employed an in-house developed XCT system consisting of a high-power X-ray tube HP-225 (Comet X-ray, Switzerland), a GPXS J10666-311 (Hamamatsu, Japan) large-area CsI scintillating screen, a Kiralux CS135MU optical camera (Thorlabs, USA), and NMV-16 16 mm f/1.4 lens (Navitar, USA). In this case, the specimen was mounted on a servo-driven rotary stage ACD175-A102 (Akrabis Systems, Singapore). The experimental setup is shown in Figure 3. The conversion of X-rays to visible light for further detection using a camera was based on a scintillating screen with a CsI conversion layer with a thickness of  $400 \mu\text{m}$  and an active area of  $468 \text{ mm} \times 468 \text{ mm}$  with a native projection resolution of  $1024 \times 1024$  pixels given by the properties of the camera sensor. Projection pre-processing included dark-field and flat-field corrections, while hot-pixel suppression in the readout of the camera sensor was enabled to deal with zingers in the projections. The X-ray source was operated at an acceleration voltage of 80 kV and a target current of 10 mA, corresponding to a target power of 800 W. The source was configured in small-spot mode with a nominal

maximum focal spot size of approximately  $400 \mu\text{m}$ . The reference acquisition protocol consisted of 3647 equiangular radiographic projections with an exposure time of 1800 ms per projection. The total acquisition time was approximately 122 min. The applied imaging geometry resulted in an isotropic voxel size of  $112.5 \mu\text{m}$ .
