Preliminary study of an ancient earthquake-proof construction technique monitoring via an innovative structural health monitoring system

Section: RESEARCH PAPER

Keywords: Anti-seismic technique; experimental test; numerical analysis; structural health monitoring systems; measurement accuracy

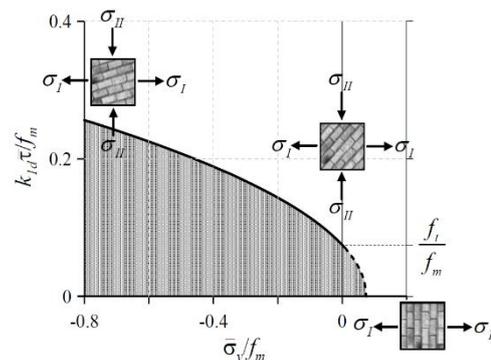
Figure 1. The failure criteria of Turnšek and Čačovič's model for masonry piers, represented in the resolved stress plane [21].

stress [24]. The failure criteria for masonry piers, which are represented in the resolved stress plane, are shown in Figure 1.

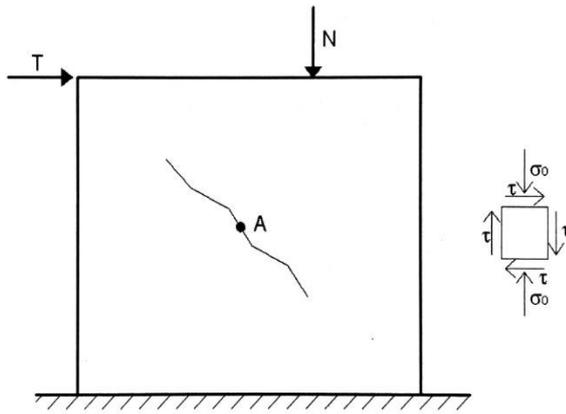
Figure 2. Adopted schematisation of the masonry block.

In the new Italian technical standards (document C8.7.1.3.1.1 7/2019) Turnšek and Čačovič's formulation is simplified in order to obtain the shear strength value of the masonry pier. Figure 2 shows the adopted schematisation of the masonry block.

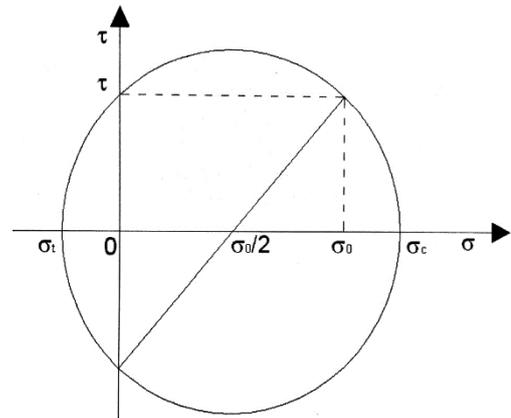
Figure 3. Tensile state at point A.

where T and N are respectively the shear and normal force applied to the masonry block and l and t are the length and thickness, respectively, of the masonry. The stress state at point A is represented by Mohr's circle in Figure 3, as characterised by centre C and radius R , which are expressed by (4) and (5):

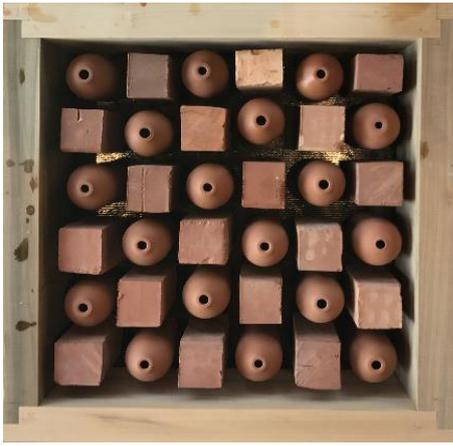
Figure 4. Arrangement of bricks and NFTs in the timber frame.

After the outer timber frame was built, the inner masonry wall was created. Here, the bricks used had a square cross section of 5.5 cm per side and a height of 13 cm. Meanwhile, the fictile tubules were new nomenclating fictile tubules (NFTs) [27], since these are produced in a pottery industry using faster, more innovative techniques before being refined on the potter's wheel. The tubules had the same height as the bricks (13 cm) and a thickness of 6 mm (Figure 4, Figure 5). The mortar had a compressive strength of around 2.5 MPa, corresponding to that labelled as M2.5 *bastarda* according to Table 11.10.IV of the 2008 Italian Building Code. This specific mortar consists of one part cement, two parts lime mortar, and nine parts sand.

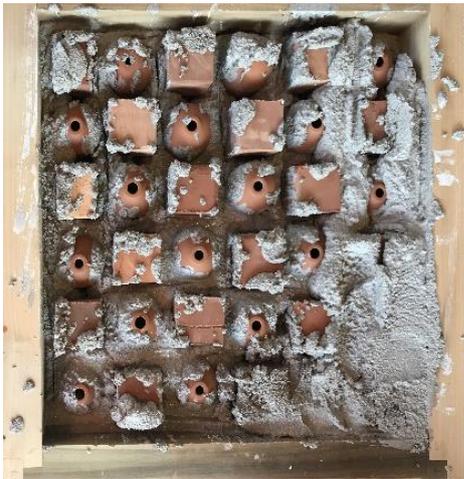
Figure 5. Mortar casting.

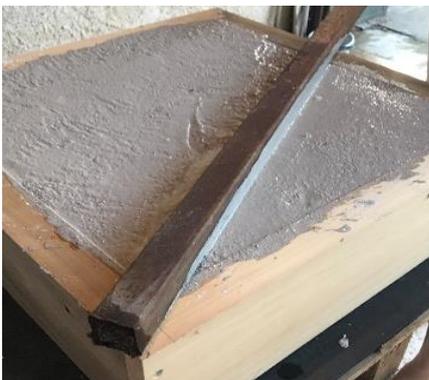
Figure 6. Creation of the upper layer of mortar.

The specimen wall was completed by casting a 2-cm-thick layer of mortar to cover the tips of the fictile tubules (Figure 6).

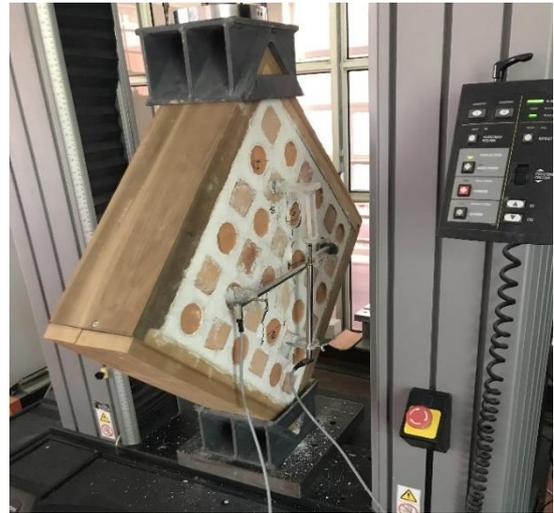
Figure 7. Set up of the test.

The diagonal compressive test was carried out by rotating the specimen wall by 45 ° before two steel caps were placed on the specimen, one at the bottom for support and the other at the top for uniformly distributing the load. The speed of the test was 0.5 mm/s. Two pairs of transducers were applied to the masonry specimen to further monitor the relative displacements. Here, the transducers labelled LVDT0 measured the vertical displacements between two bricks, while those labelled LVDT1 measured the horizontal displacements between two ficile tubules (Figure 7).

Another transducer with the same characteristics as those used for calculating the displacements of the masonry was positioned near the upper part of the load cell in order to measure the lowering of the cross member of the test machine.

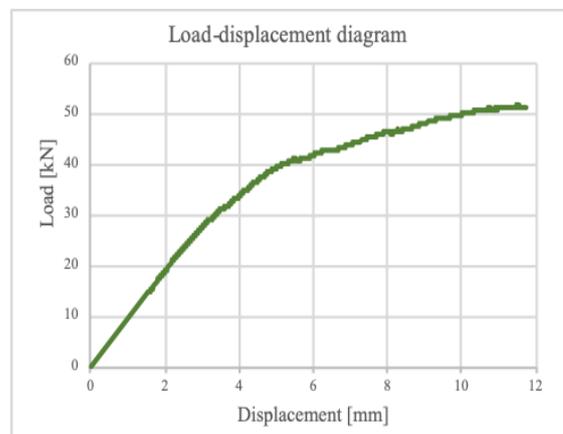
Figure 8. Load displacement diagram.

The load displacement diagram is presented in Figure 8. Here, following a linear elastic branch up to 80 % of the maximum load, the elastic modulus decreased until reaching a plateau, where the peak load was attained and was found to be 51.48 kN. At this load value, the displacement of the load cell, as recorded by the third transducer, was 11.526 mm. The hardening branch was most likely due to the friction between the mortar and the ficile tubules elements, as well as to the overall compressive stress state of the specimen wall.

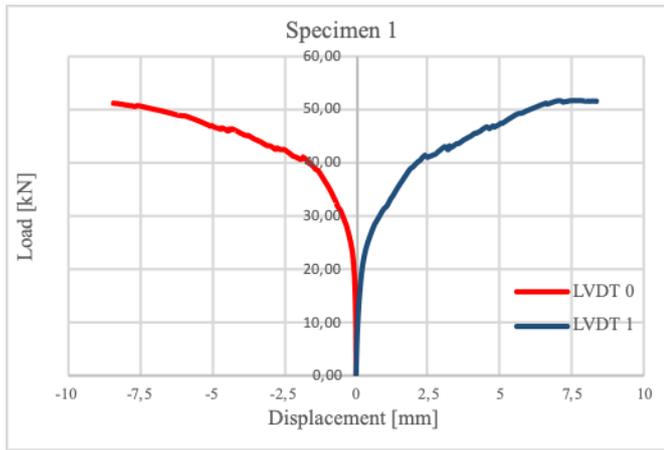
Figure 9. Load vs. displacement diagrams of the transducers for specimen 1.

Figure 9 shows the load vs. displacement diagrams recorded via transducers LVDT0 and LVDT1 during the test.

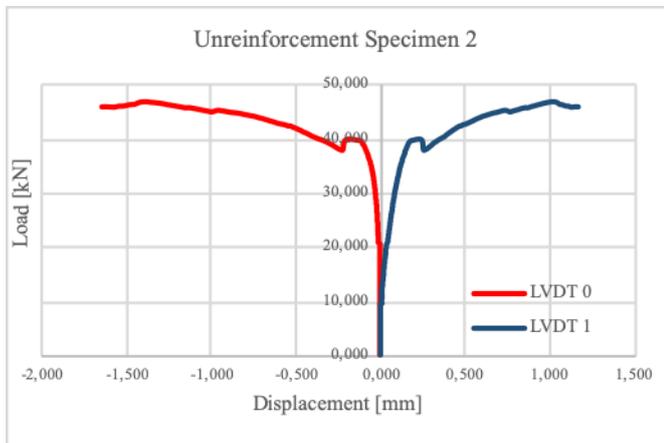
Figure 10. Load vs. displacement diagrams of transducers for unreinforced specimen 2.

The same test set up was used to analyse specimen number 2. In this case, the test was stopped at the formation of the first damage and when the diagram arrived at the end of a linear elastic branch. The recorded peak load was 46.77 kN (Figure 10).

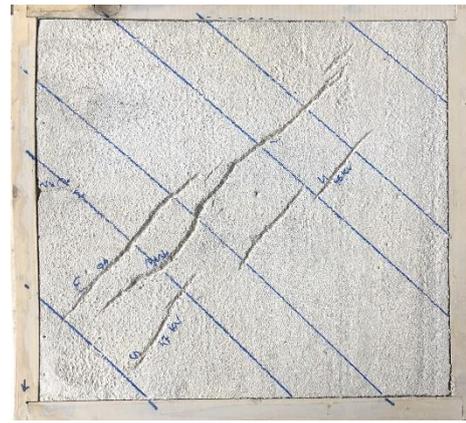
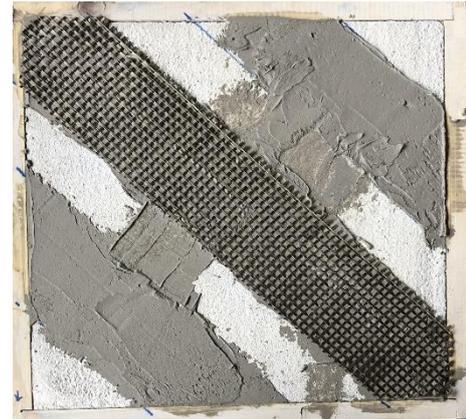
Figure 11. Specimen 2 before and after reinforcement.

When damage began to develop in the specimen, the test was stopped, and the specimen was repaired and reinforced. Three B-FRCM strips of 100 mm were placed at the side of the wall featuring a 2-cm layer of mortar (Figure 11). The B-FRCM strips were chosen since compatibility with the support was ensured and since they are characterised by a tensile strength and a Young's modulus of 134 MPa and 19 GPa, respectively, while those for basalt fibres are generally 301.5 MPa and 16 GPa [11]. In order to measure the strains on the strips, two strain gauges were applied to the central strip in relation to the fibres perpendicular to the cracks. Following this, the test was repeated on the reinforced specimen until it collapsed.

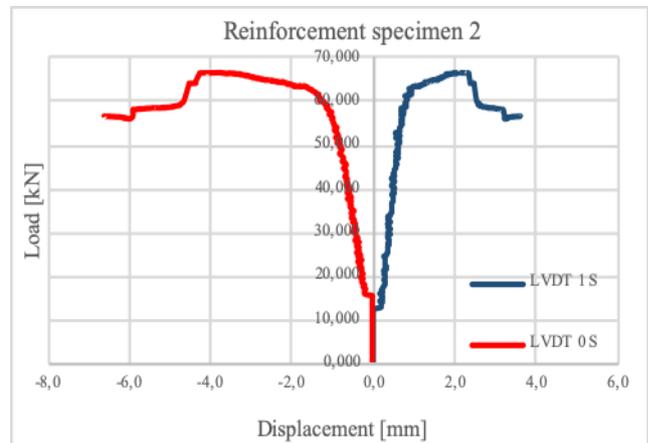
Figure 12. Load vs. displacement diagrams of the transducers for reinforcement of specimen 2.

The maximum value of the load recorded during the reinforcement test was 66.48 kN (Figure 12). At this load value, a failure of the B-FRCM reinforcement occurred [30], which was due to the debonding following the cohesive failure of the substrate (Figure 13).

The main problem that emerged during the second test on the second specimen was the return of the LVDT data. As indicated by the elastic branch of the load vs. displacement diagram presented in Figure 12, there was a disturbance caused by a noise that was due to the DAQ. Meanwhile, the data acquired by the channels dedicated to the strain gauges did not present this problem. As such, a spline fitness function was implemented to minimise the effect of the noise, thus preserving the linearity of the load vs. displacement graphs to obtain new diagrams, which are presented in Figure 17. Here, a cubic spline interpolation algorithm was used on the acquired data, with the spline function smoothing the random trend due to the noise, which allowed for highlighting the load vs. displacement trend.

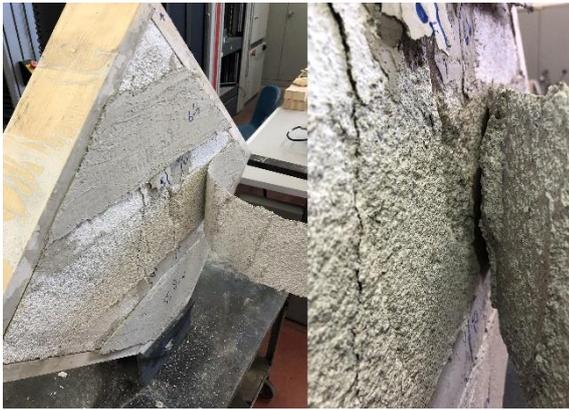
Figure 13. Collapse of the reinforcement strip.

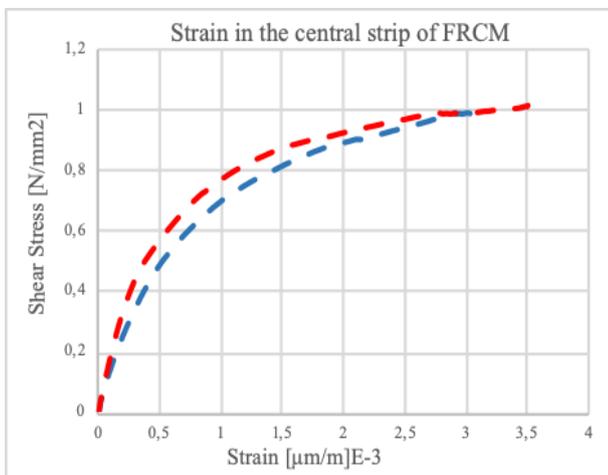
Figure 14. Shear stress vs. strain diagram.

Figure 14 shows the shear stress vs. strain diagram obtained during the test conducted on the reinforced specimen. Here, the shear stress was evaluated using Eq. 9 and was found to be 1.04 MPa.

The average value of the strain recorded during the test by the two strain gauges was 3.25 [$\mu\text{m}/\text{m}$] E-3. This value was in line with that prescribed by the manufacturer of the fibre, that is, a range of 3–3.5 [$\mu\text{m}/\text{m}$] E-3.

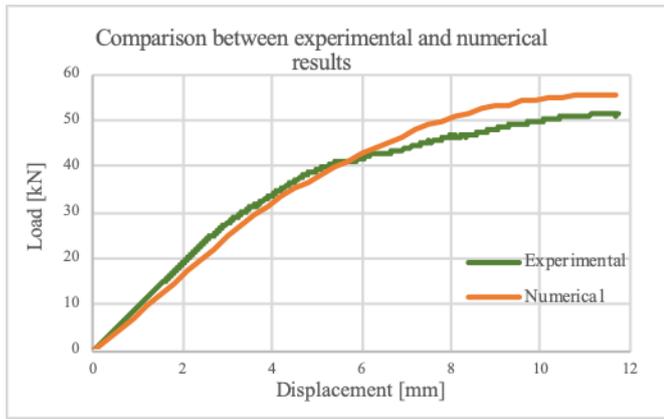
Figure 15. Shear stress vs. strain diagram comparison.

The comparison between the numerical and experimental load displacement diagrams is shown in Figure 15. The numerical analysis satisfactorily estimated the linear elastic branch of the graph, but the peak load attained was 8 % higher than the experimental load (55.54 vs. 51.48 kN). In addition, the numerical analysis was halted for an ultimate displacement that

was close to that related to the load peak recorded during the experimental test. In fact, the displacement obtained by the numerical model was 11.700 mm, while the experimental displacement was 11.526 mm.

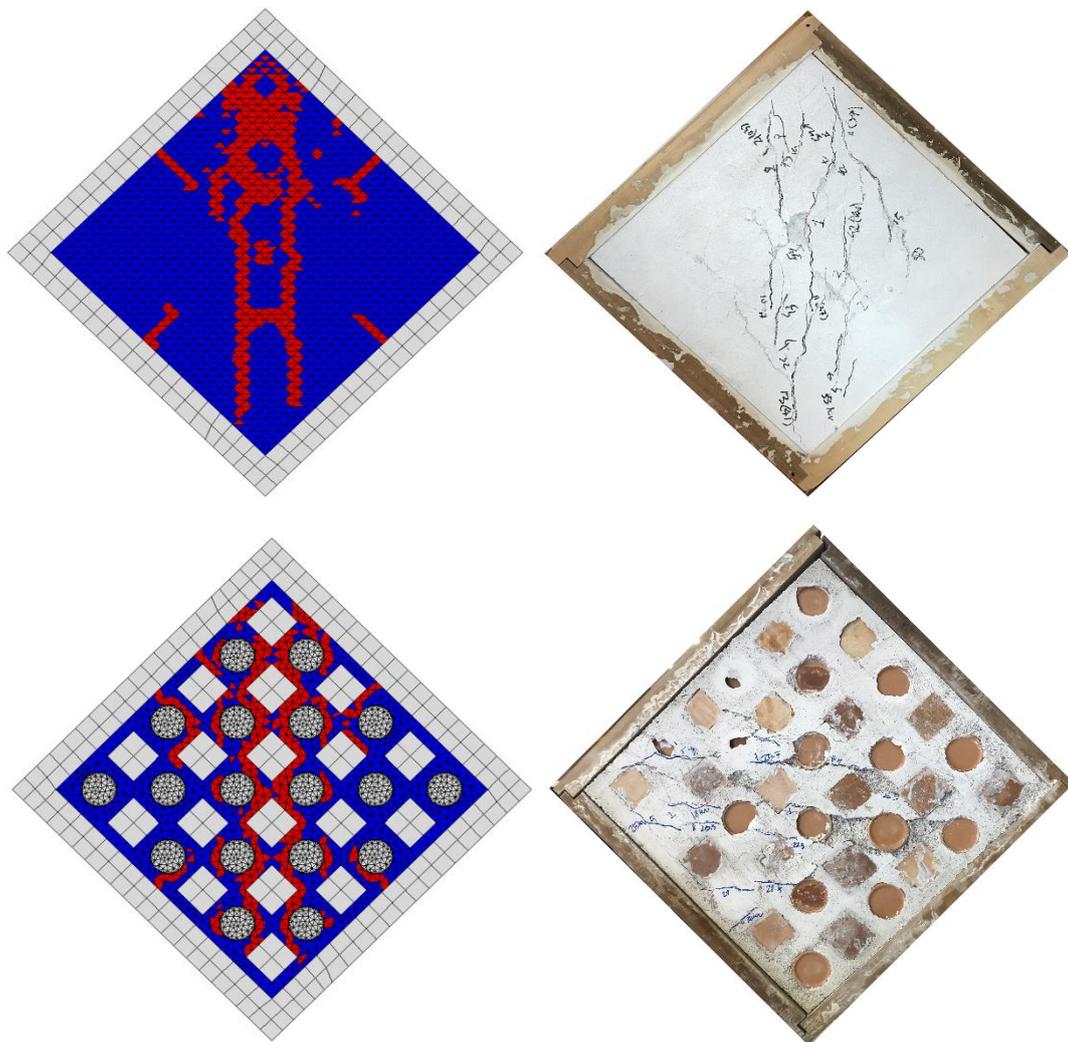
Figure 16. Comparison of crack development in the back and front side of the numerical model and the experimental specimen wall.

The damage in the numerical model corresponded to the experimental outcome, while more cracks were present at the top, as were four single cracks originating at the mid-section of each timber beam. Given the overall fair correspondence in

terms of crack patterns, it can be assumed that these four single cracks appeared only for numerical reasons, meaning they played no significant role in the overall response of the numerical model (Figure 16).

Figure 18 shows the location of the cracks developed during the testing of the first specimen following the attainment of the maximum load. On both sides of the masonry wall, cracks developed through the mortar, parallel both to each other and to the direction of the load application, while they barely affected the fictile tubules. The numerical simulation demonstrated good agreement in terms of the load displacement diagrams, albeit with some minor discrepancies, while the crack development largely mirrored that obtained in the experimental test. In addition, the simulation of the damage in the wall obtained via the numerical model largely corresponded to the experimental results, while more cracks appeared at the top as well as four single cracks originating at the middle section of each timber beam. Overall, the model was highly similar to the actual situation, with the four small cracks noted above appearing in the back of the wall.

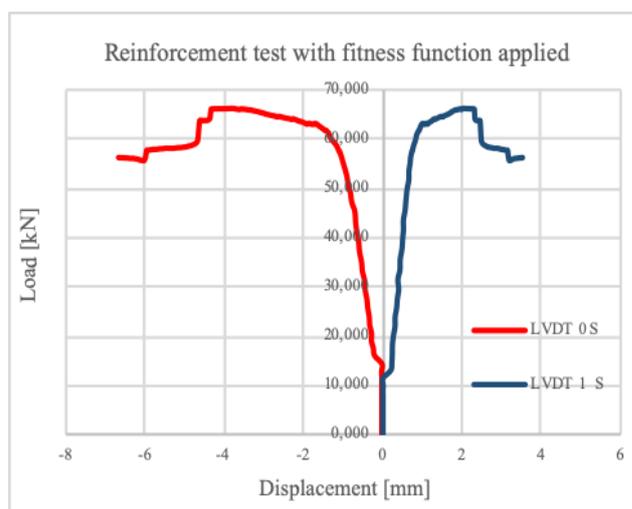
Figure 17. Load vs. displacement diagrams following the application of the fitness function.
