Digital surveying and 3D modelling structural shape pipelines for instability monitoring in historical buildings: a strategy of versatile mesh models for ruined and endangered heritage

Section: RESEARCH PAPER

3. AN EXPERIMENTAL CASE STUDY: THE CHURCH OF THE ANNUNCIATION IN POKCHA (RUSSIA)

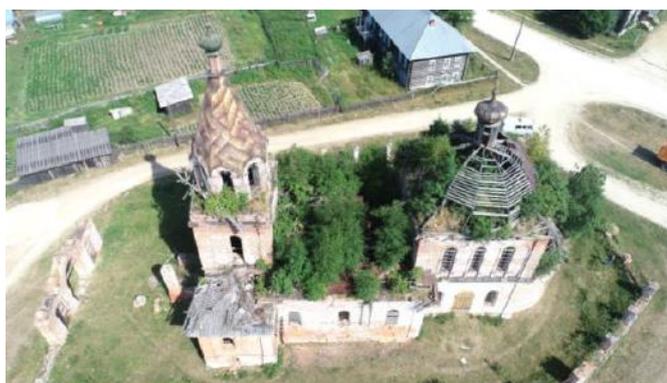
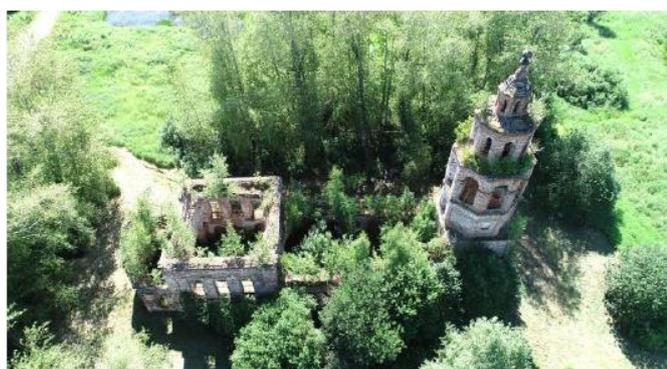
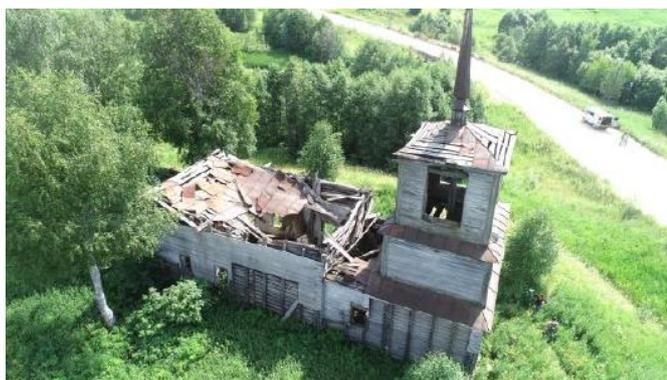
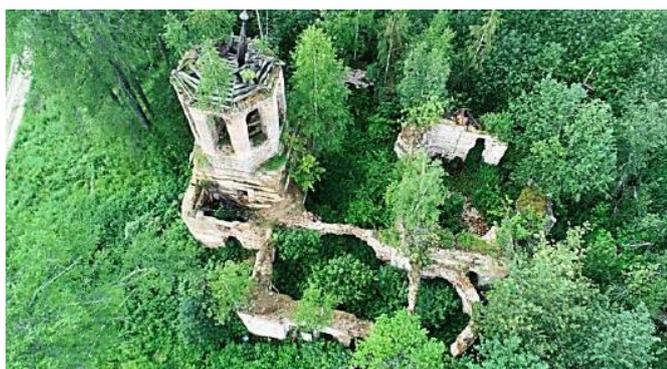
Figure 1. Examples of sites along the Upper Kama route characterised by on-going risks of abandonment and decay, proving the basis for a classification as endangered heritage. From the top, Church of the Exaltation of the Holy Cross in Bondjug, Rubezhskaya Church in Usolye, Church of St. Nicholas in Uzhginskay, Church of Paraskeva Friday in Saltanovo.

Historical buildings are traditionally founded on and remain linked to their original structural system, from the construction phase to later procedures. The demolition of bearing systems and elevations, the reconfiguration of horizontal levels and vaults, and the construction of expansion blocks thus enrich the mechanical experience of the monument (Figure 1).

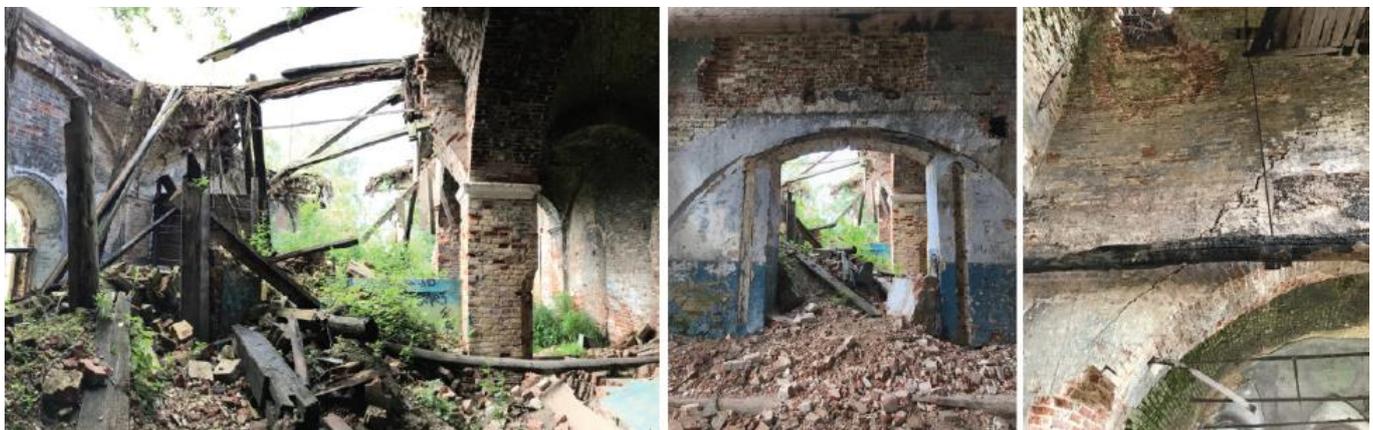
Figure 2. The state of neglect and the lack of conservation present critical situations of widespread instability among the masonry systems, clearly exposing the structure to the damage affecting its elements. Robustness instabilities in the structural complex of the Church of the Transfiguration, Pyskor, defining the increasing frameworks of damage that will destroy these buildings without specific lines of intervention.

The consideration of structural diagnosis applied to historical built heritage in terms of the knowledge of the stress behaviours and the prevision of damage mechanisms plays a central role in the development of the documentation protocols for safeguarding. A review of the risks, the on-going kinematics, and the priorities of stability related to endangered buildings [8] places the focus on the aspect of robustness, that is, the capacity of the building and its elements to withstand a certain level of stress imposed by a combination of degradation and the changes in both the materials and the environments [9]. Thus, considering the deep impact that stress-altering phenomena have on the geometrical and material aspects of buildings (e.g. deformations, drifts, cracks) is part of a comprehensive diagnosis that can be achieved through an investigation into the structural shape [10]. As such, it is possible to focus the evaluation of the stress instabilities on the target of a ‘static morphology’ that reflects the mechanical and stress traces left by the adaptation schemes of the system during its physical history. It also highlights the stability principles related to the class and type of resistant geometries (Figure 2).

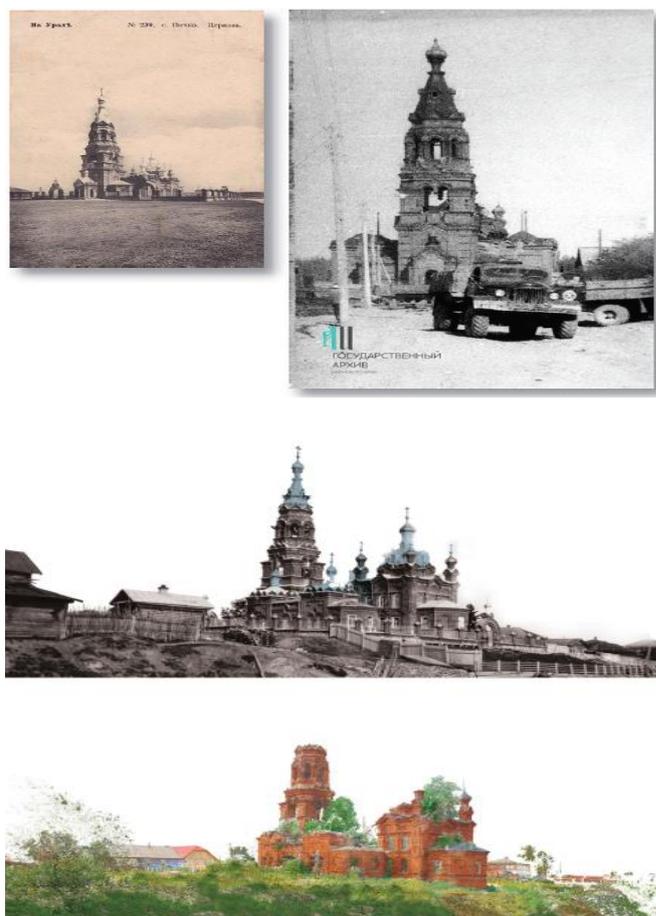
Figure 3. The complex of Blagoveshchenskaya Church in Pokcha. The original architectural structure of the church before the revolution in 1956 (above) and the ruins as of 2018 (below).

The case of Blagoveshchenskaya Church, or the Church of the Annunciation of the Blessed Virgin, in the village of Pokcha, represents a key monumental site of the Cherdyn district, which synthesises various different historical-functional evolutions in the stratification of its structures and walls, which today lie in ruin [17], Figure 3.

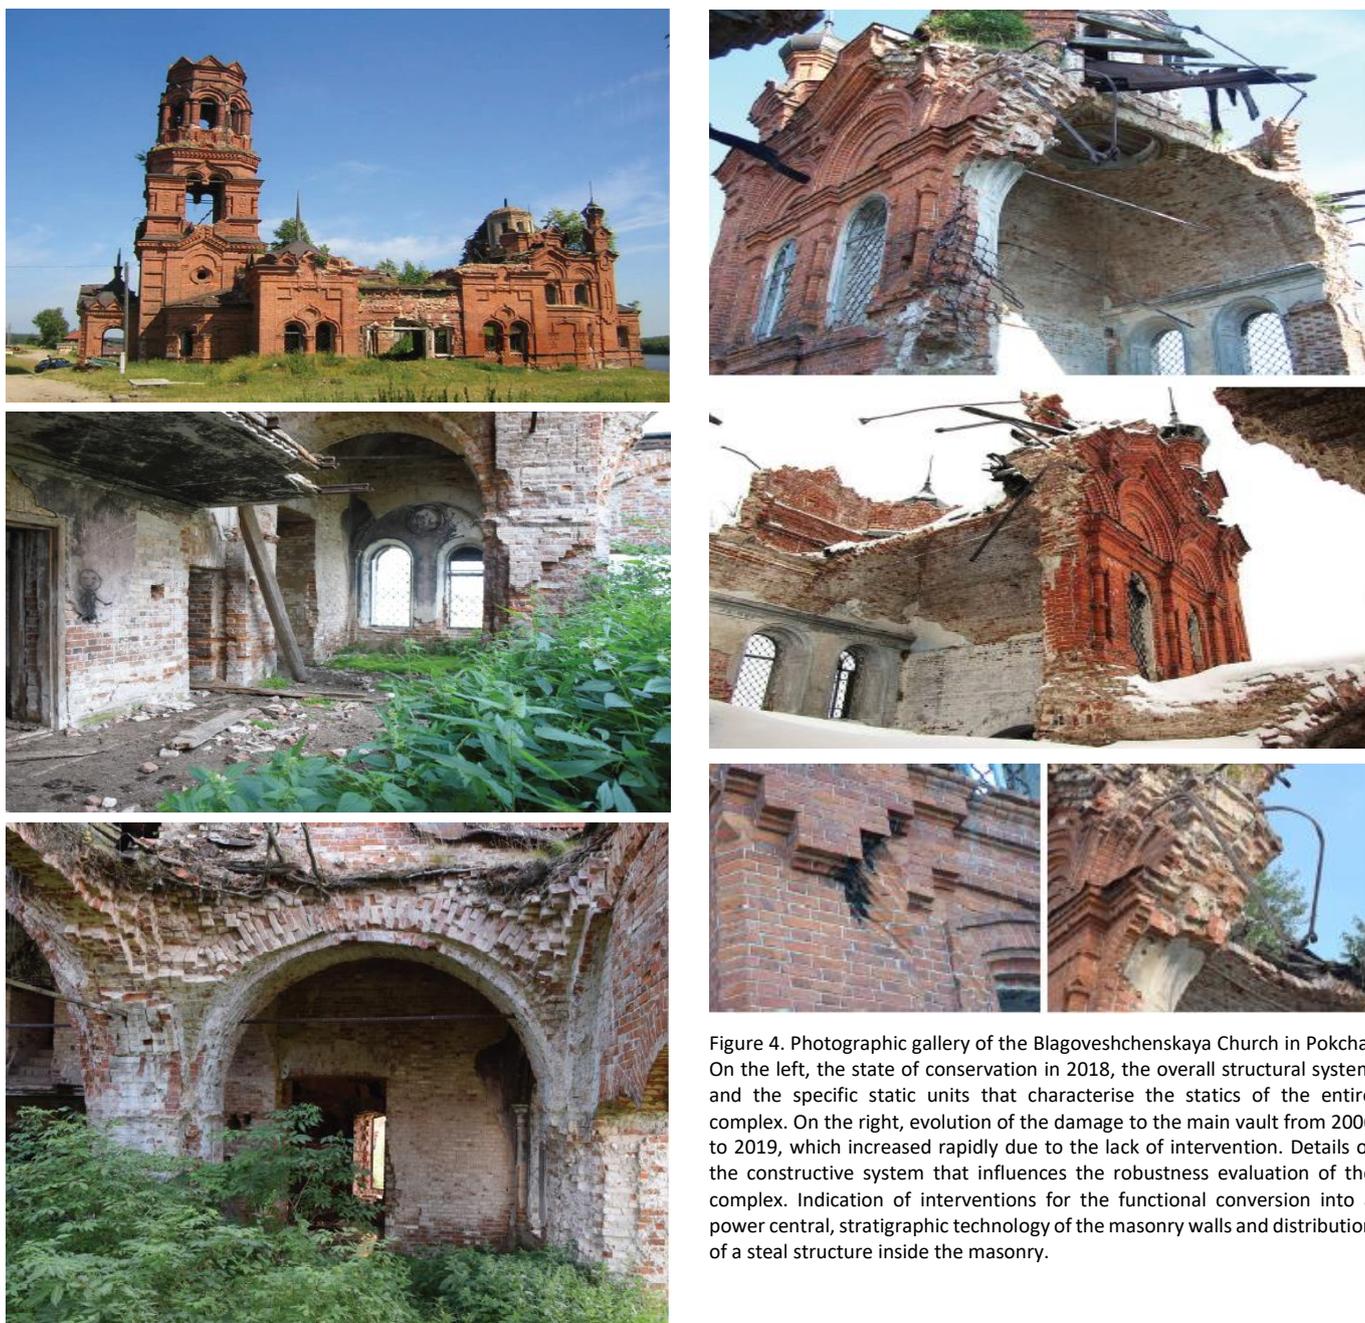
Figure 4. Photographic gallery of the Blagoveshchenskaya Church in Pokcha. On the left, the state of conservation in 2018, the overall structural system and the specific static units that characterise the statics of the entire complex. On the right, evolution of the damage to the main vault from 2006 to 2019, which increased rapidly due to the lack of intervention. Details of the constructive system that influences the robustness evaluation of the complex. Indication of interventions for the functional conversion into a power central, stratigraphic technology of the masonry walls and distribution of a steel structure inside the masonry.

particularly affected by the frequent presence of herds in transhumance, often housed by the shepherds inside the church during the summer season (Figure 4).

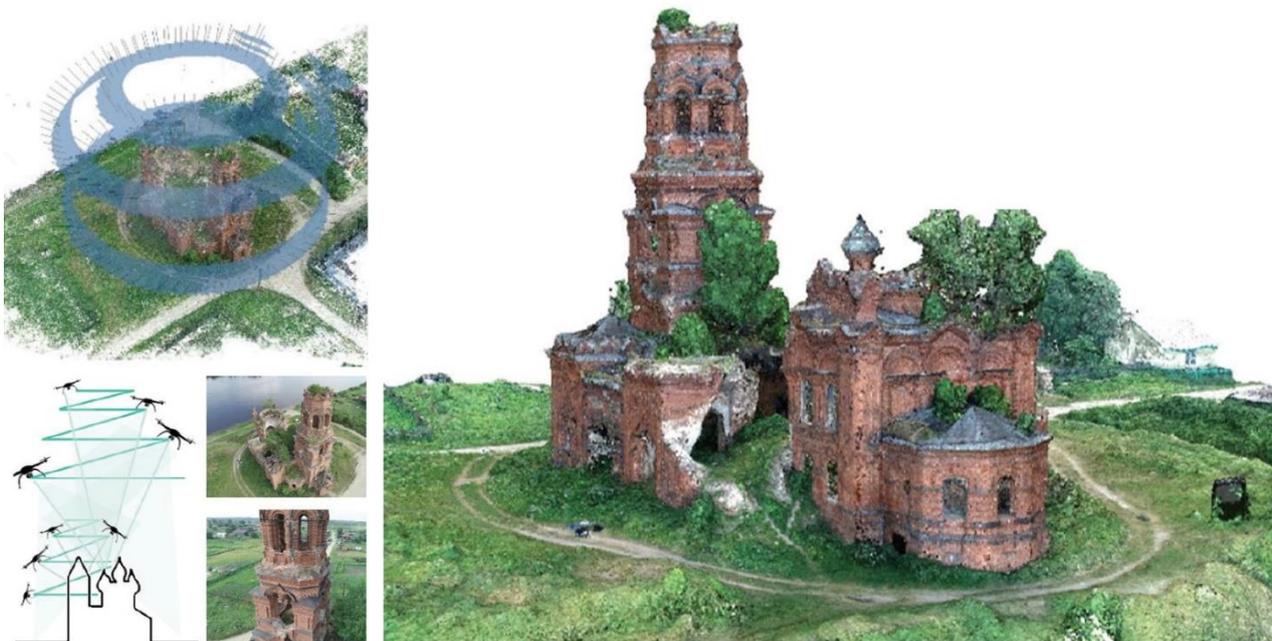
Figure 6. Morphometric database from the on-site photogrammetric UAV acquisition campaign: the photos were geo-referenced and aligned to define the main point cloud on the architectural complex and the surrounding landscape.

At the same time, the aerial photogrammetric acquisition was developed using an unmanned aerial vehicle (UAV, DJI Phantom 4 Pro), with the flight plan focused on the points of interest of the architectural complex. In fact, the flight plan mission was set from the top centre of the complex at a level of 50 m from the ground in the mode ‘point of interest’. Here, a photogrammetric campaign was conducted using the aerial camera with a conical acquisition surrounding the monumental complex, descending to a height of 10 m above ground and developing 329 shots in 10 min of flight. The guaranteed camera angle and the adjustable inclination of the gimbal allowed for total coverage of the top surfaces, with a quality of photographic data suitable for the clear photogrammetric reconstruction of the edges of the components (21 MPixel). In addition, specific flight plans for the tower blocks and the central vault were planned with greater photographic detail, largely due to the close distance of shooting. The GPS coordinates defined by the UAV for each shot better addressed the alignment algorithms, set to ‘high’ precision, simplifying the alignment of the photogrammetric structure from motion (SfM) reconstruction. In terms of the overall SfM point cloud, there was an error of 0.004 pixels due to the camera alignment (Figure 6).

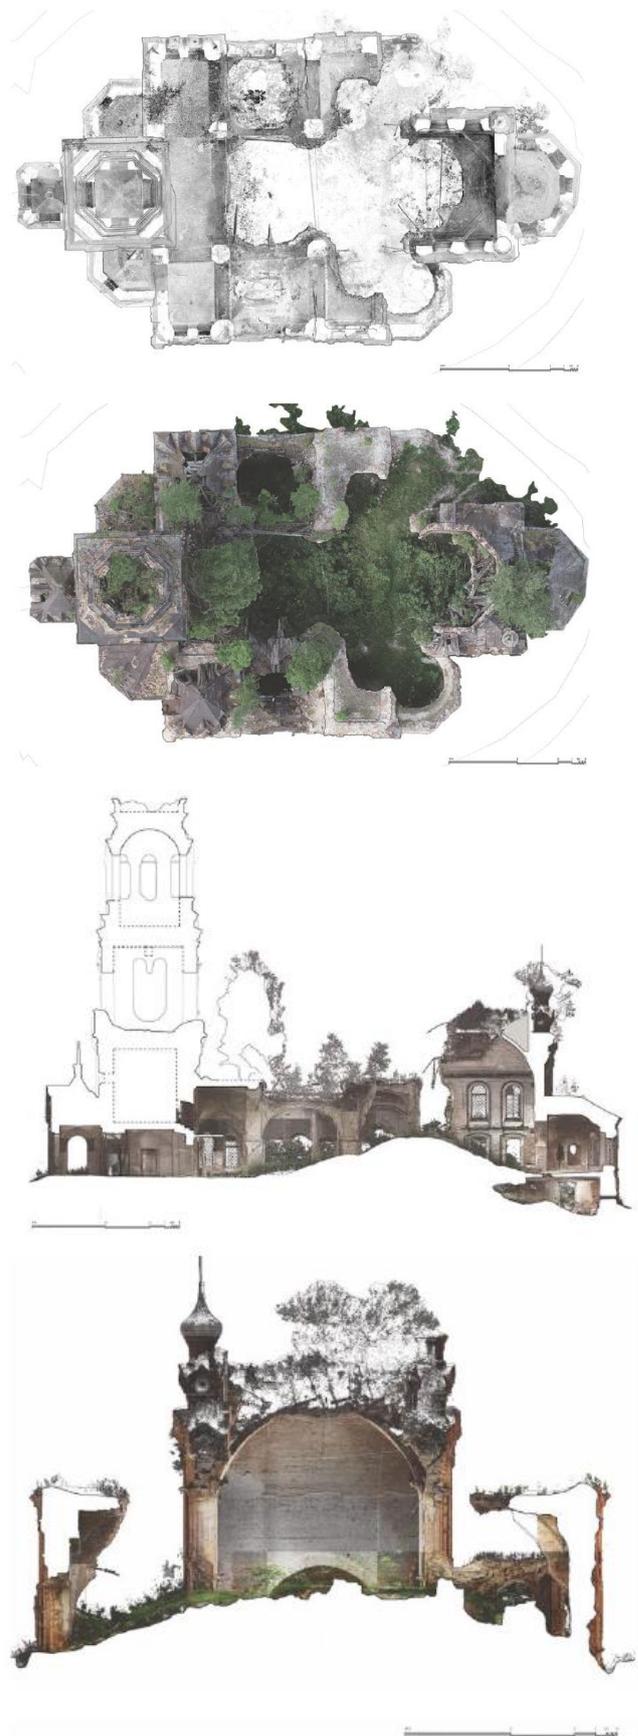
Figure 7. Drawings and elaborations for the 2D description of the main structural system of the church. The presence of noise data for elements such as the vegetation and collapsed ruins is highlighted.

The aim of the structural representation was focused on the development of a continuous mesh modelling protocol, enriched with reality-based qualities, achieved as part of the objective of digitally surveying detailed and imperfect shapes as confirmed by the instability and mechanical features. These shapes, controlled and certified within the envelope of the structural object, necessarily introduce a need to manage the polygonal geometric mesh that defines them, the processes of which are, however, improved by the representation of a morphological detail that is itself a source of diagnostic reflections on the mechanisms of analytical systems [22] [24], Figure 7.
