MA-XRF measurement for corrosion assessment on bronze artefacts

Abstract – In this study, an innovative portable macro X-Ray Fluorescence (MA-XRF) scanner prototype has been employed in order to gain information on composition and distribution of corrosion products artificially grown on Cu-based coupons. First results have shown the importance of using artificially corroded reference samples before any assessment on archaeological artefacts. Moreover, the prototype used demonstrated to be a powerful tool for understanding complex corrosion processes which might occur on Cu-based alloys. The scanner was able to detect light elements as S and Cl, essential for studying the distribution of specific corrosion compounds. Using imaging techniques, it was possible to observe a gradient in Cu elemental maps intensity caused by the overlapping of a thicker corrosion product layer.

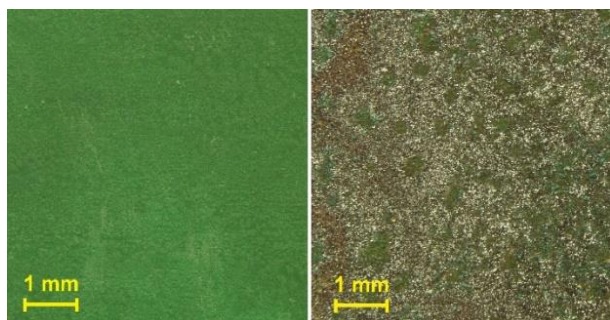
Fig. 1. Artificially corroded layers: CW (left) and sulphate (right) samples. High resolution images.

The study has been performed on Cu 99.96 wt%, reference coupons ($45 \times 15 \times 5 \text{ mm}^3$). The specimens were polished with 500 to 4000 grid SiC paper, rinsed in ethanol in ultrasonic bath for 5 min, and well dried. Then, two kind of artificial corrosion layers have been produced by chemical synthesis (Fig. 1): a set of samples (*sulphate sample*) was created by immersion in a 0.1 M Na_2SO_4 solution for three months at room temperature in order to obtain a sulphate corrosion layer. The other set of samples (*CW sample*) was created by immersion in a Corrosive Water solution (CW, $2.8 \cdot 10^{-2}$ M NaCl, 0.01 M Na_2SO_4 , $16.1 \cdot 10^{-2}$ M NaHCO_3), that is an ASTM D1384 solution modified by Constantinides [2], for 7 months at room temperature in order to obtain a complex corroded layer. Both solutions were neither stirred nor aerated by bubbling.

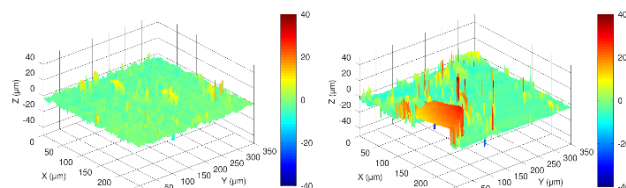
Fig. 2 shows, as an example, the confocal microscope images acquired on some of the copper reference samples. The *CW sample* presents a quite smooth surface structure with a standard deviation of about 2.7 μm ; the *sulphate sample* instead presents a more heterogeneous morphology with surface roughness values of about 6.1 μm .

Fig. 2. Confocal microscope images of the CW (left) and sulphate (right) corroded layers.

The roughness can be one of the major geometrical variables that affect the scanner performance, therefore a comparison of roughness and the sum map can show the presence of a geometrical factor that can create a sort of distortion on the scanner response. If the statistics are enough, one can hypothesize using an elemental map image as a mask to account for any roughness contribution to the final images.

The corrosion product layer thickness can vary greatly, and it depends on the nature of the products present and the alloy. As an approximation, its thickness can vary from 40 to 138 μm in the case of tin bronzes and from 14 to 146 μm in the case of quaternary bronzes [20]. Therefore, it is unlikely that, in this case, roughness would cause any significant distortion in the elemental distribution maps.

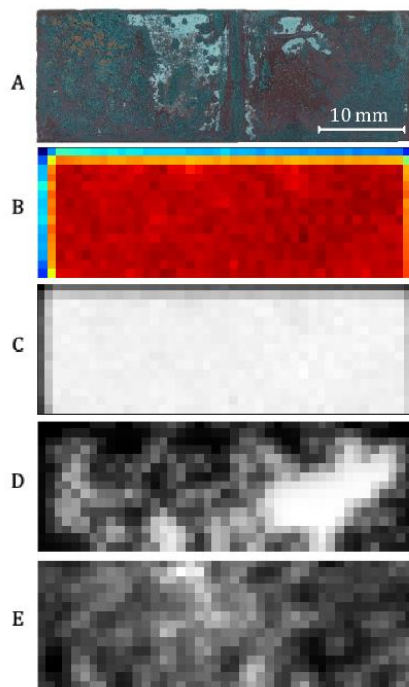
In fact, when applying an average-threshold filter to the copper maps one can observe a certain gradient in the intensity values. The reasons can be three-fold: the formation of a variable-in thickness corrosion layer which attenuates (proportionally to its thickness) the signal from the copper atoms underneath or a selective/preferential corrosion of copper atoms or lastly a distortion caused merely by the surface's roughness. Carefully inspecting the elemental maps of copper and sulphur from the sulphate sample and the sample's aspect (Fig. 3), it is reasonable that what caused a gradient in the copper intensity values in this sample is the presence of a thicker corrosion product area (lighter area, Fig. 3A) in the upper part of the sample surface.

Fig. 3. Sulphate sample surface (A) and scans: (B) sum map, (C) copper map, (D) filtered copper map and (E) sulphur map.

Nonetheless, sulphur was detected across the *sulphate sample's* surface (as expected) and formed a seemingly gradient that spreads from the upper-middle portion towards the lower region (Fig. 3E). Chlorine could not be detected due to its significantly lower counts and signal contamination from the sample holder (made of polyvinylchloride). Whereas for the *CW sample*, sulphur could not be detected, and chlorine could be mapped only when applying a low-pass filter to the elemental distribution map cutting off a portion of the contamination signal coming from the sample holder in the bottom right part (Fig. 5E).

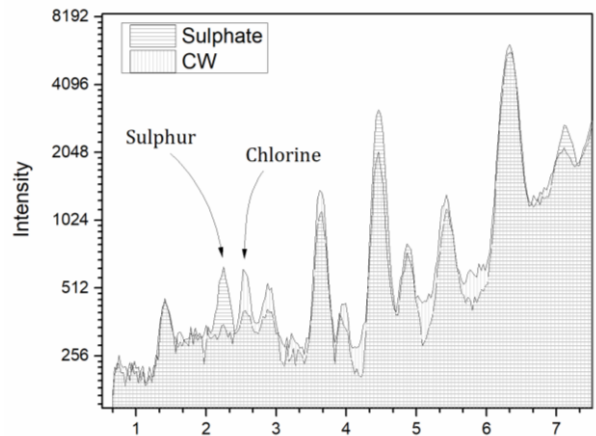
Concerning the corrosion components distribution across the sample surface, the chemical elements identified are either sulphur or chlorine (since carbon and oxygen cannot be detected by the instrument): being light (low Z) atoms, their counts statistics is considerably low (Fig. 4).

Fig. 4. Sum spectra comparison of samples sulphate and CW. Arrows point to S-K α and Cl-K α lines.

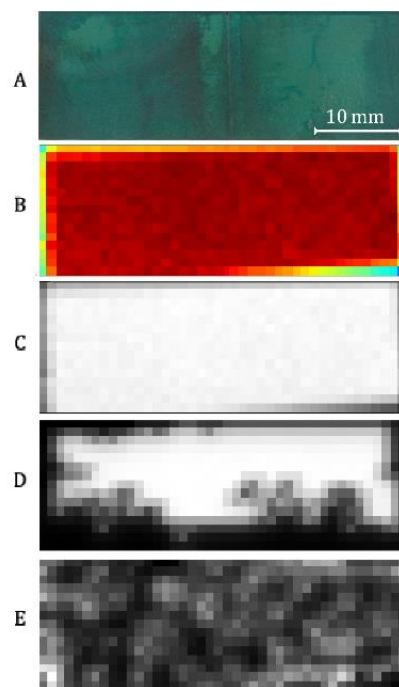
Fig. 5. CW sample surface (A) and scans: (B) sum map, (C) copper map, (D) filtered copper map and (E) chlorine map.

Differently from what was observed in the *sulphate sample*, the corrosion products distribution did not follow any specific “macro” pattern, nor did the copper distribution map shown any gradient (Fig. 5). The reason may be the distribution of chlorine and the corrosion products formation process. Constantinides et al. [2] demonstrated through artificially corroded Cu-alloys that chlorine is preferably deposited in an inner layer, in between the alloy’s bulk and the outer corrosion layer. This preferential deposition is created by a mechanism originating from mechanical stress or chemical reaction, where cracking occurs in the surface and promotes pitting corrosion. This process causes a further dissolution of the alloy, producing more Cu^+ cations which reacts with Cl^- anions present in the solution, as a result CuCl and CuCl_2 are formed and built up in an internal layer to the corrosion surface. Even though the formation of chlorine compounds is propelled in this mechanism, the net weight concentration of chlorine is still relatively low (when compared to the alloying elements concentration and the system detection limit), commonly about 2 wt%. Moreover, considering that chlorine is deposited underneath a Cu-oxide layer, its detection by the MA-XRF system is further hindered by attenuation effects.
