Castiglioni Chapel in Pavia: a methodological approach for documentation and virtualisation techniques

Elisabetta Doria¹, Francesca Galasso², Marco Morandotti³

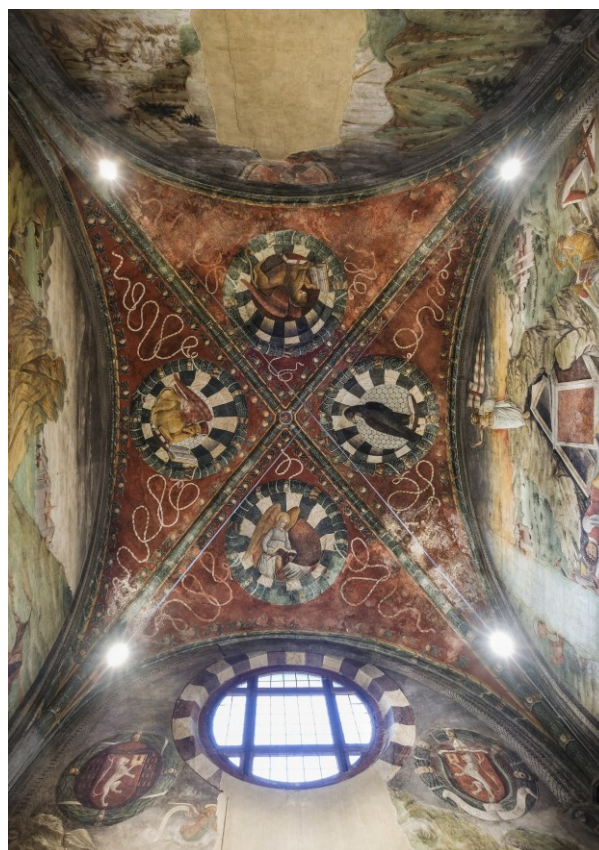
Fig. 1 Intrados of the vault of the Castiglioni Chapel and evident deterioration of the wall frescoes.

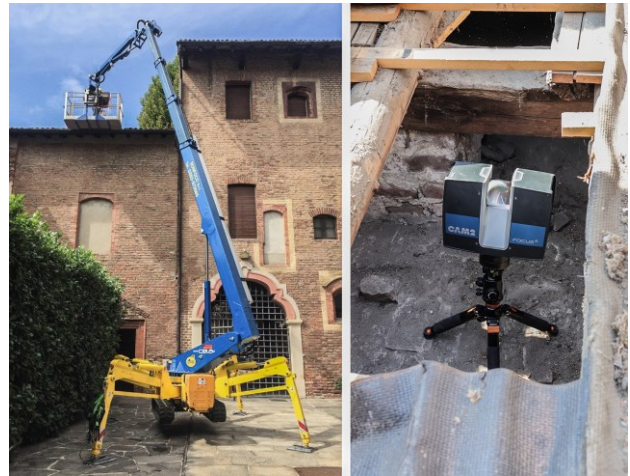
Fig. 5 Elevator platform used to access the extrados of the Chapel vault.

The use of the elevator platform, necessary for accessibility, complicated the laser scanner survey due to the intrinsic mechanical vibrations of the elevation vehicle. In order to use the laser scanner inside the attic, it was necessary to use specific trestles and tripods given the reduced height and the need for inclination.
