Structural degradation measurement and diagnostics of historical masonry buildings.

Sangiorgio Valentino[1], Martiradonna Silvia[2], Fatiguso Fabio[3], Uva Giuseppina[4]

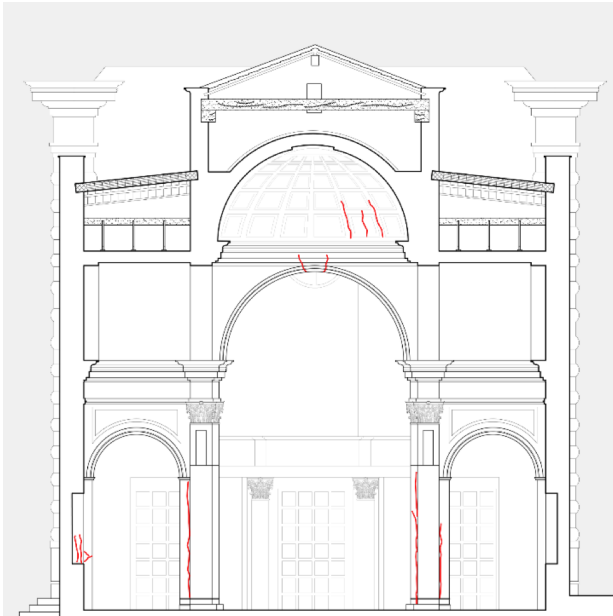
Fig.4. Survey forms: damaged Pillar

Finally, the global index is evaluated by considering all the components of the structure. The global index, $I_{STRUCTURE}$ results equal to 1.52 in a scale between 0 and 10. This index points out that the overall structural condition is good and only few damages occur on the Church. On the other hand, the few damages surveyed by the survey forms may be serious. More in-depth investigations are needed as suggested by the I_M (Fig. 4) and I_C (Fig. 5) that reach values higher than 7 in a range between 0 and 10.
