# Preliminary study for the preservation of two natural horns from the end of the 17th century

Michela Albano[1,2], Giacomo Fiocco[1,3], Piercarlo Dondi[1,4], Francesca Tasso[5], Valentina Ricetti[5], Daniela Comelli[2], Maurizio Licchelli[6], Claudio Canevari[7], Marco Malagodi[1,7]

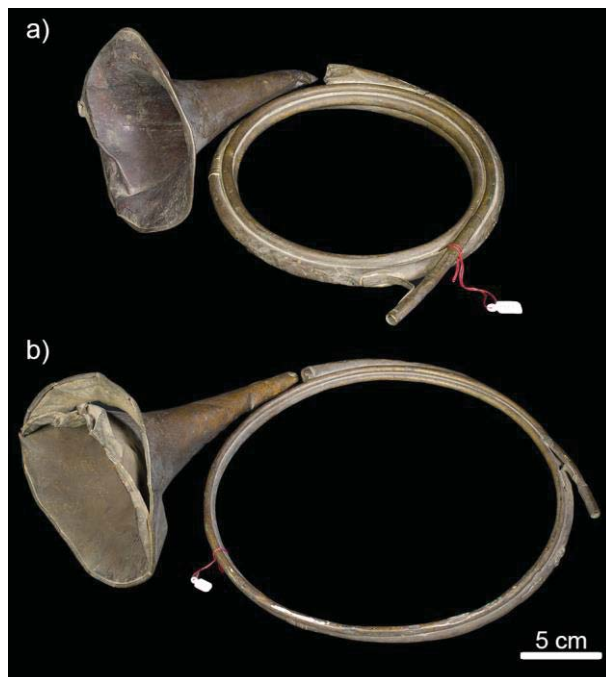
The horn made by Wolf bears the inscription "MACHT / JOHANN / HAAS / NURNBERG" and the initials "IWH" above a leaping hare turning backwards its head, while the other one by the father Johann, bears the hare keeping its face forwards [12]. The bells and the tubes were detached, some parts were lacking, and the surface suffered from different kinds of alteration.

*Fig. 1. a) inv.878 by Johann Wilhelm Haas (1649-1723); b) inv.877 by Wolf Wilhelm Haas (1681-1760).*

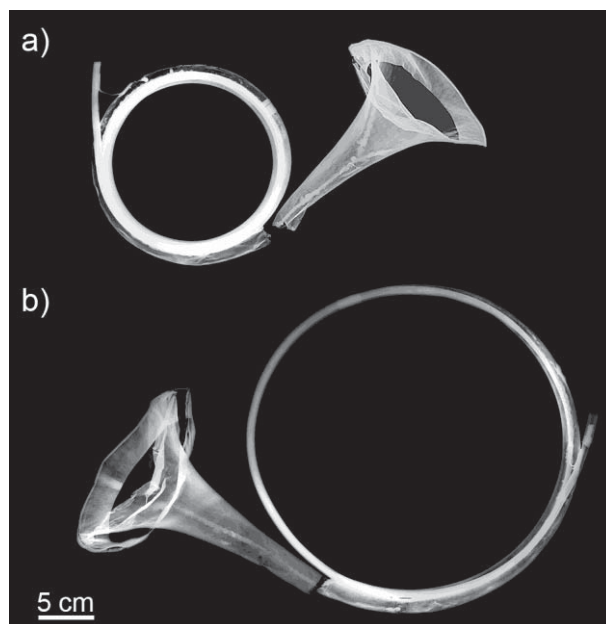
The structural features help to access the manufacturing processes and to identify the damages and eventually the presence of some reparation or restoration action. X-ray radiography (Fig. 2) showed up, for both the instruments, numerous patches, and cracks: a magnification of some of their visible traces on the external surface have been documented by stereoscopy and showed in Fig. 3a. Moreover, brazing, jointing, and in some cases the accretions found agglomerated on the inner surface of tubes have been highlighted as well. The investigation suggested that the *inv.878* (Fig. 2a) was characterized by a

*Fig. 2. X-Ray radiography respectively of the inv.878 by Johann Wilhelm Haas (a) and on the inv.877 by Wolf Wilhelm Haas (b).*

by X-Ray radiography: the presence of the "gusset" which is a "V" shaped lamina inserted with a nipped tooth joint generally added to prevent too much stretching of the edge during the hammering and in order to produce a larger bell (Fig. 2a); the difference in the optical density around the ring that divide the tube and that seems to join two laminas of two different thickness. The bell of the *inv.877* could be made of a uniform lamina, thinner than the one of the other bell, characterized by numerous cracks and it recognizable by the unique metal joint (Fig. 2b).

By radiography (Fig.2b), the tube appeared as a single folded element as expected in the traditional executive technique [13]. Also, in this case numerous deformations of the lamina, macroscopic cracks, and areas of soldering and reparations were highlighted. Part of the soldering showed a coarse aspect that could be correlated to later restorations (Fig, 3d).

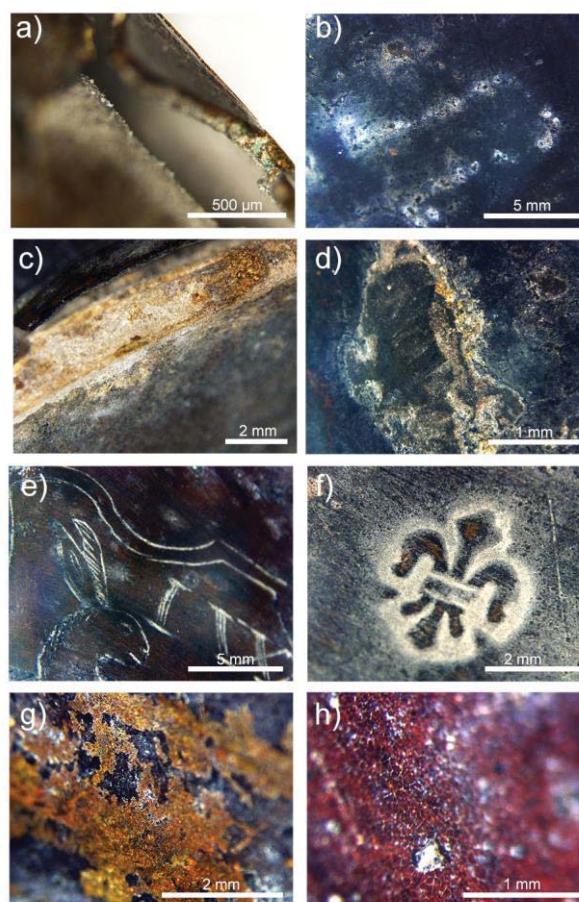
uniform thickness and by a nipped tooth joint between the edges of the lamina (Fig. 3b).

Moreover, the detail of the metal thread shown in Fig. 3c, confirmed a traditional building of the garland that was the standard bell finishing method of early brasses before the industrial revolution. Sheets of brass were cut in a "Y" shape, folded, brazed, and hammered over a mandrel. The garland was then fitted over the edge without soldering. On the outside of the bell, the position of an original support between the bell and the tube is proven by a leftover part [13].

The stereoscopic examination revealed many chromatic and morphological alterations of the surface. Most of them could be the products of the chemical reaction of the materials with the environment. The deposition of the white dusty and adherent deposits inside the engravings and the punching (Fig. 3e and f) could be the consequences of an inappropriate cleaning of the surface. Finally, the documentation of a superimposed layer characterized by red particles suggests the presence of a surface pigmented treatment (Fig, 3g). In fact, in many cases as a common practice, a varnish was applied to give shine and protection to the metal alloy after polishing the surface [8]. A peculiar aspect of both horns, and more evident in the *inv.878* by J. W. Haas, is also the reddish surface inside the bell, (Fig. 3h) that could be due to a peculiar finishing. In fact, the finishing the inner side of the bell with dull coating or a fine decoration was a common practice as well.

*Fig. 3. Details magnification by stereomicroscope: a) crack on the tube (inv. 877); b) nipped tooth joint (inv. 878); c) metal thread in the garland (inv.877); d) reparation (inv.878); e) and f) white dusty leftovers inside the engravings and the punching (inv.877); g) possible leftover treatment on the surface (inv.878); h) reddish surface inside the bell (inv.878).*

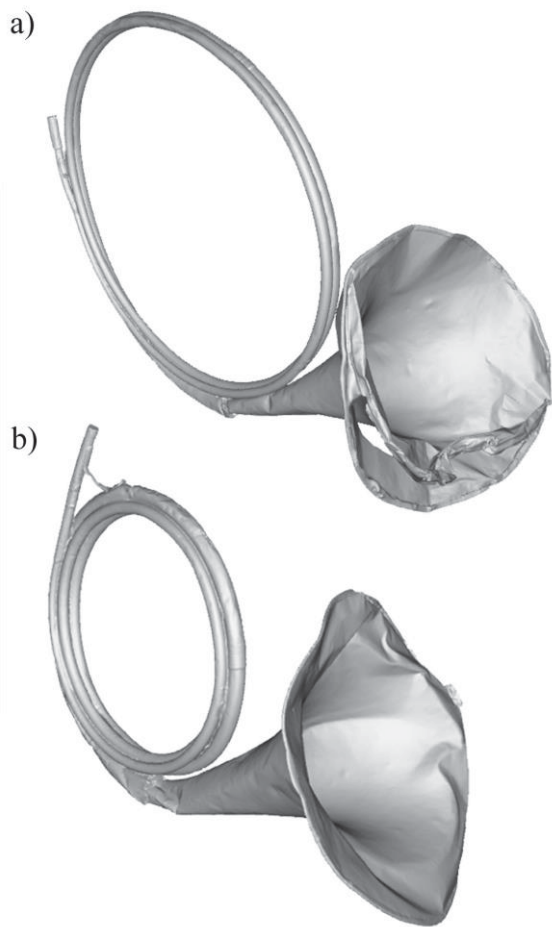
instruments. The main problems during the acquisition have been represented by the dark areas along the conjunctions of the pipes and the surface deformations. It was observed that these issues can limit the acquisition capabilities of the laser scanner: the first one was the less critical, since the geometries of the pipes are relatively regular and the missing areas could be reconstructed with a high accuracy; the second problem, instead, severely limited the capability of the laser scanner to reach the areas under the deformations. In this case, a manual reconstruction of the partially acquired areas, has been performed. The highly deformed areas did not undergo to the reconstruction process because of the too few data acquired.

Luckily, the strongest deformations were mainly focused on the border of the bells and just in the broken connection

*Fig. 4. 3D models of the two horns inv.877 (a) and inv.878 (b).*

between the two parts of the horns, while the pipes deformations were not critical for the acquisition. Thus, the 3D models were properly acquired by the laser scanner

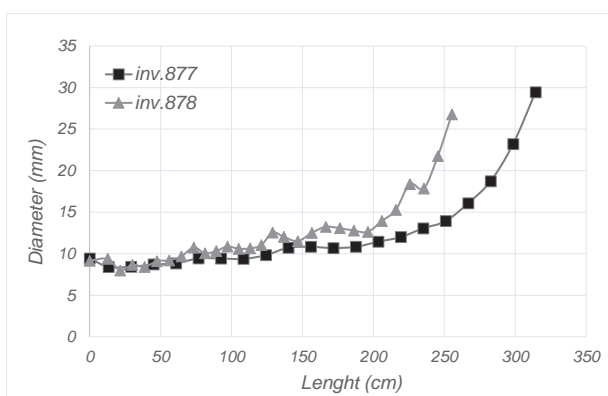
*Fig. 5. Plot of the pipe diameters size, from the mouth to the bell, for the two instruments. On the x axis, the length of the tube is reported.*

Research was primarily focused on the length and the diameter of the pipes. In fact, for the horns the pitch depends on the pipe's length, and the tuning to the shape of the instrument. Tube of *inv.877* is about 3.15 m long and is coiled into two turns. The inside diameter of the pipe coils varies between 378.9 mm and 380.5 mm, while the outside one varies between 398.5 mm and 411.6 mm. The tube of *inv.878* is shorter, only 2.55 m long, but it is characterized by three coils. The internal diameter varies between 199.3 mm and 202.2 mm, while the external one between 240.4 mm and 246.9 mm. Fig. 5 was obtained by the measurements of the diameters along the length of the pipes, acquired by the software, starting from the leadpipe with a regular step of 30 mm. Part of the values are displayed in Table 1. The plot describes a higher variability of the size diameter in the *inv.878* pipe with respect to the pipe of *inv.877*, explained by the presence of greater irregularity and deformations.

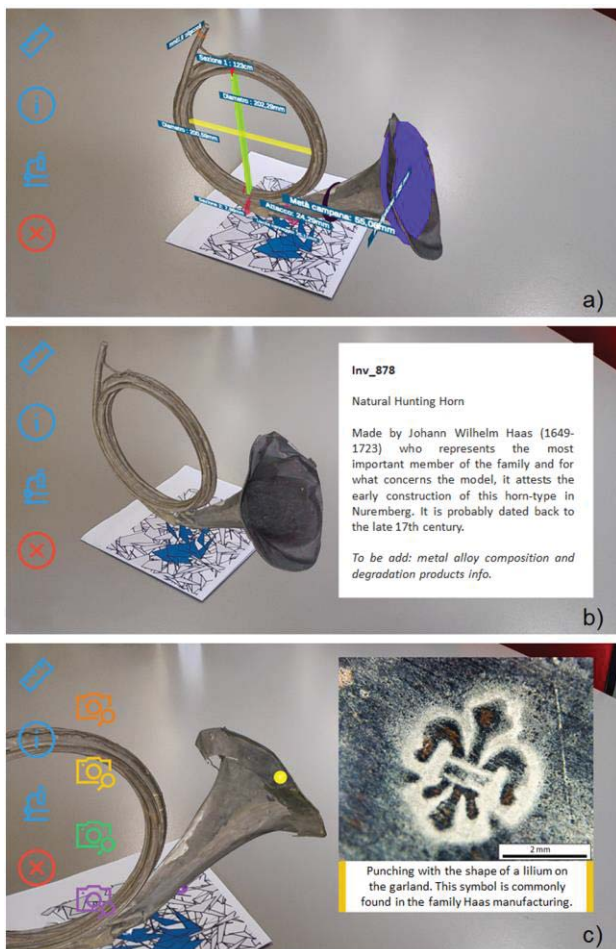
*Fig. 6. The AR application: (a) full view of the 3D model of inv878 on its marker, with some significant measures overlapped; (b) information about the chemical composition of the horn; (c) macro with description of a detail of the bell and correspondent position on the 3D model marked by a yellow circle.*

on a smartphone. The four controls on the left side of the screen (the ruler, the 'i', the microscope and the 'x') allowed us to show: significant measures on the 3D model (Fig. 6a); historical and chemical information about the horns (Fig. 6b); and macro images of meaningful details (Fig. 6c). In Fig. 6c, a second list of colored icons are shown on the right of the previous one. These camera icons appear after clicking the microscope icon; each of them permits to visualize a specific macro image taken of different spot of the surface of the horn. Moreover, the correspondent areas on the 3D models are marked by small circles of the same color, to be easily identified.
